Sustainable water network management in Lempäälä municipality

Bachelor's thesis
25th August 2012
Degree Programme in
Environmental Engineering
Tampere University of
Applied science

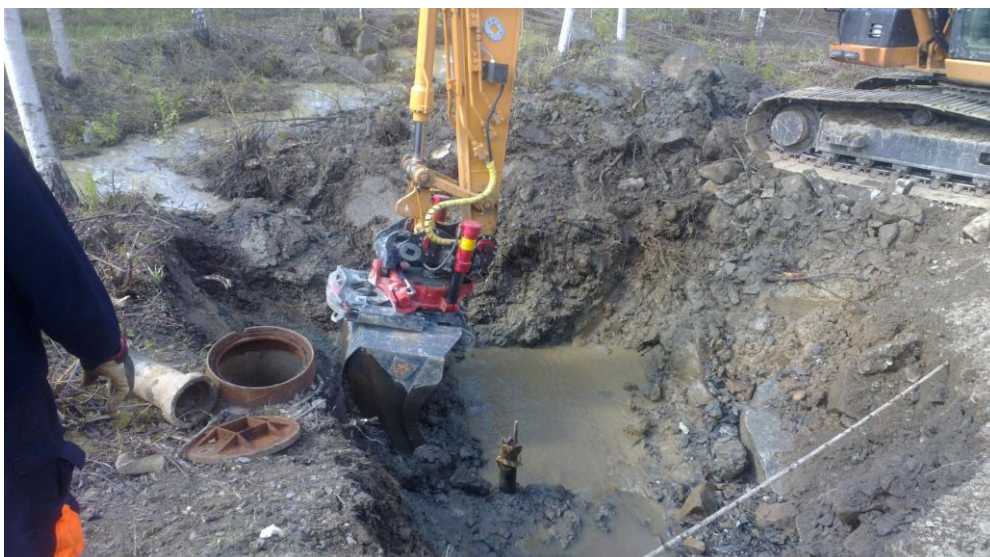
PICTURE 3.1. Excavation happening to find out the leaking point (Chowdhury 2012)

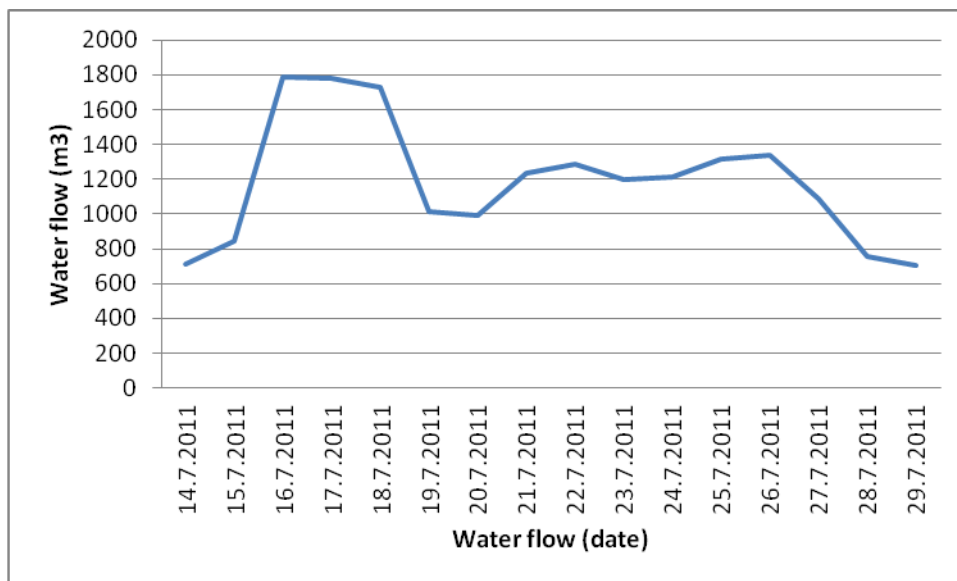
FIGURE 6.1. The volume of water flow in the pure water network

FIGURE 6.1. shows that the water flow started increasing from 14th July 2011 and as it was repaired on 26th July 2011, the flow rate started to decrease. The leakage generated 6500 m³ of lost water.

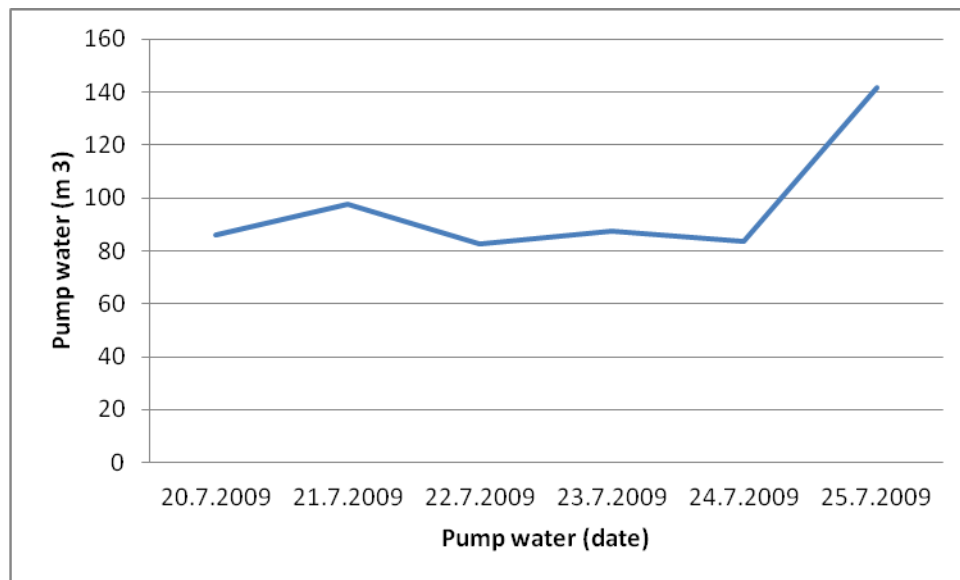
FIGURE 6.2. The volume of pumped water in the waste water network

From the FIGURE 6.2., it can be easily identified that the volume of pumping water suddenly increased from 24th July 2009. It continued till 7th July 2011, when the leak was repaired.

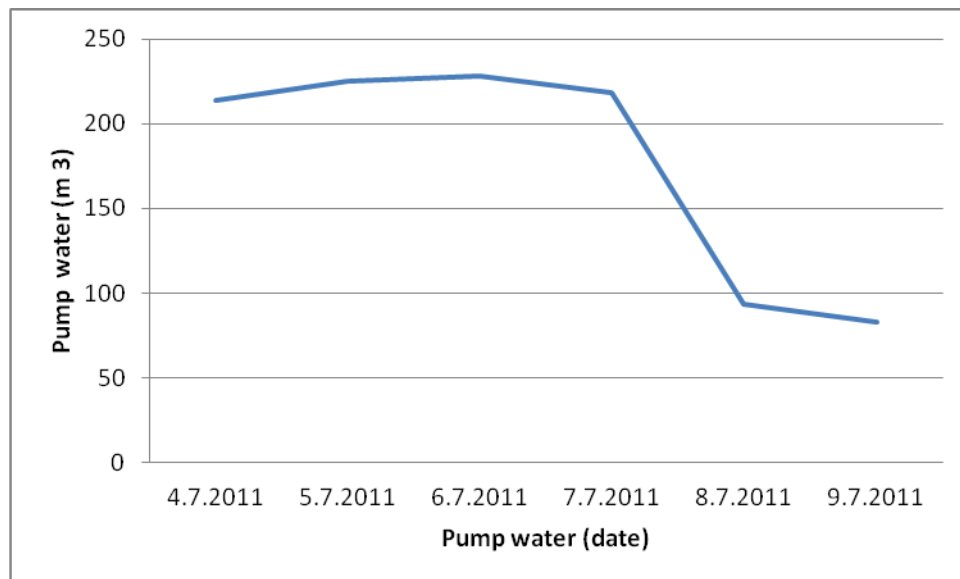
FIGURE 6.3. The volume of pumped water in the waste water network

FIGURE 6.3. shows that the volume of pumping waste water suddenly decreases on 8th July 2011. It happened just after the next day of repair work.

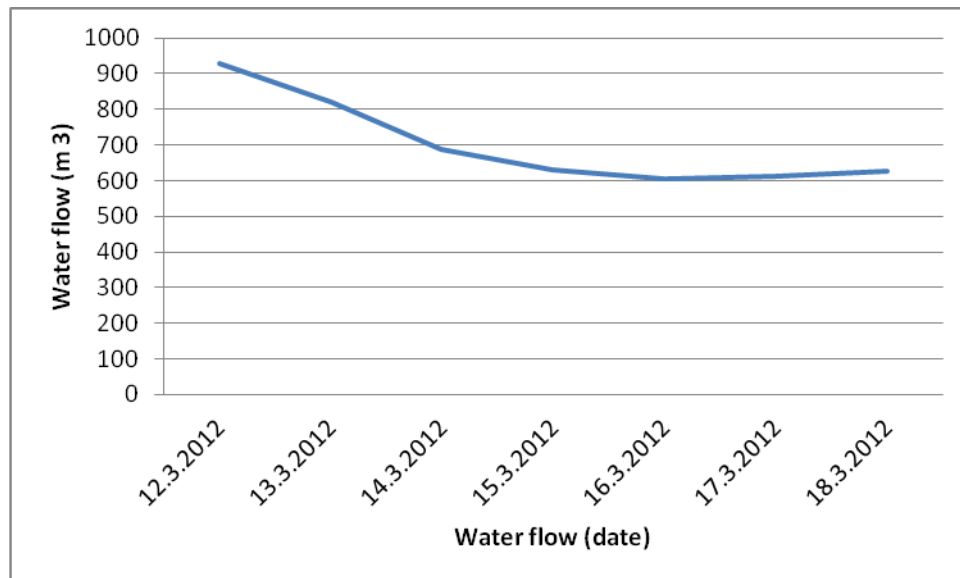
FIGURE 6.4. The volume of water flow in the pure water network

In second case, the volume of water entered into the waste water network was 4500 m³. The water also went to Välimäki pumping station and in the same way, reached to the treatment plant.

FIGURE 6.4. shows that the water flow in the pure water network started to decrease after the repair work done on 12th March 2012.

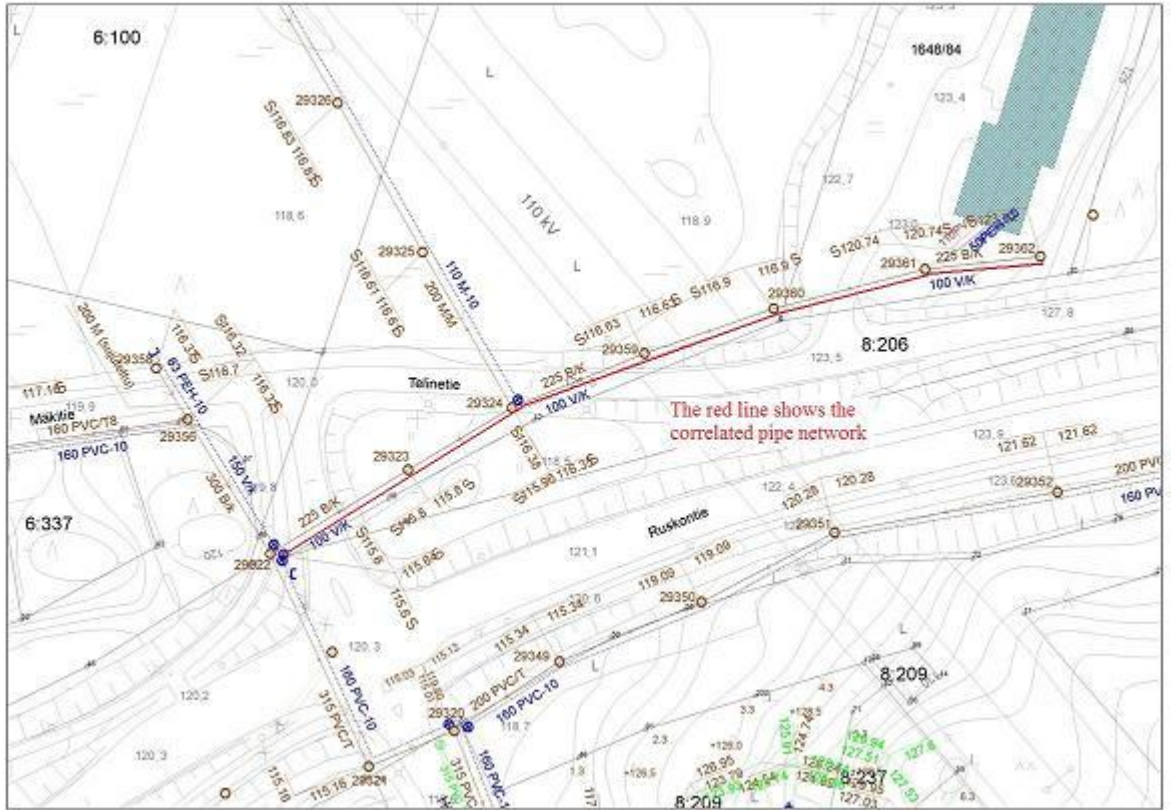
Appendix 1: Map of first correlated pipe network

The first correlation was done for fire hydrant 78. Pipe lines near that places were correlated in three directions and all correlations showed that the leak was in the valve of a house connection. The valve was next to manhole 13319 in the cross roads but there was no water in the pipe around the valve and also no water entered into the manhole next to the valve. The fire hydrant was listened again and finally came up to the result was that there might be a leak also in the connection of the fire hydrant.
