# Improving Yield on Testing Stations

Metropolia Ammattikorkeakoulu

Bachelor's Thesis

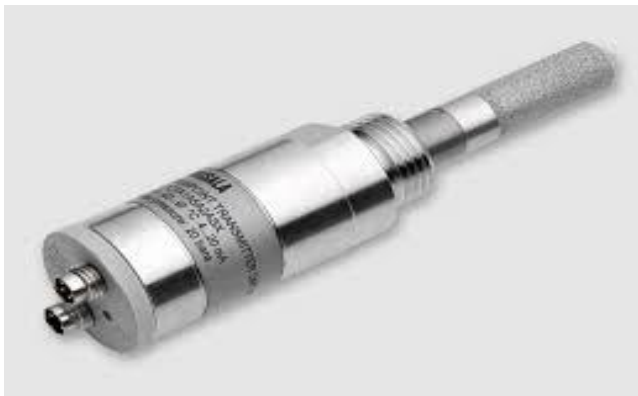
Figure 1 DMT143 [14.]

Vaisala's DMT143 is a dew point transmitter suitable for measuring wide range of industrial applications. Its measuring range is from  $-70^{\circ}\text{C}$  to  $+60^{\circ}\text{C}$ . This device was selected because it can reach all calibration points on multiple Vaisala's dew point transmitter calibration runs, and it was mounted on the other testing station which is the usual testing station for these devices. [4.]

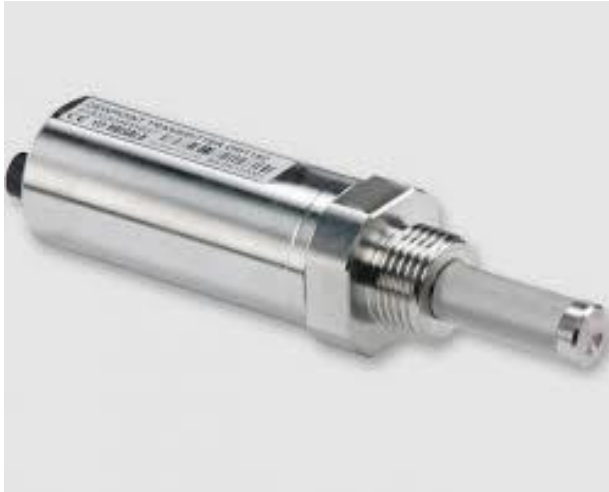
Figure 2 DMT152 [14.]

Vaisala's DMT152 is a dewpoint transmitter designed for low dew points down to  $-80^{\circ}\text{C}$ . The device was selected because one of the testing stations is mostly used for calibrating DMT152 devices, and lower dewpoint transmitter was needed since DMT143 can only reach  $-70^{\circ}\text{C}$ . [5.]

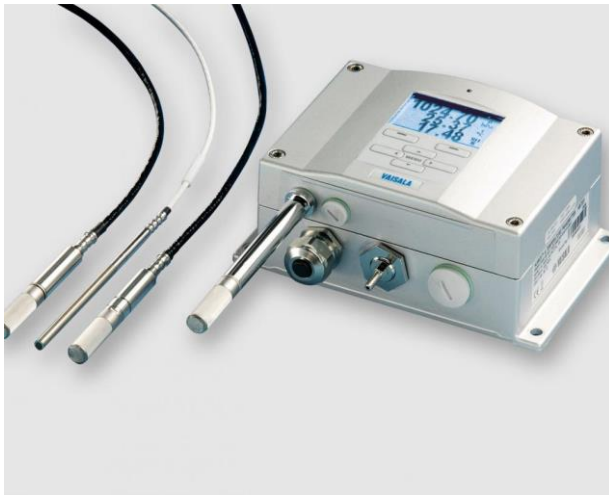
Figure 3 PTU300 [14.]

Vaisala's PTU300 series devices are a pressure, temperature, and humidity transmitters. PTU301 was used in this project to measure pressure, though it is capable of three different measurements. [7.]

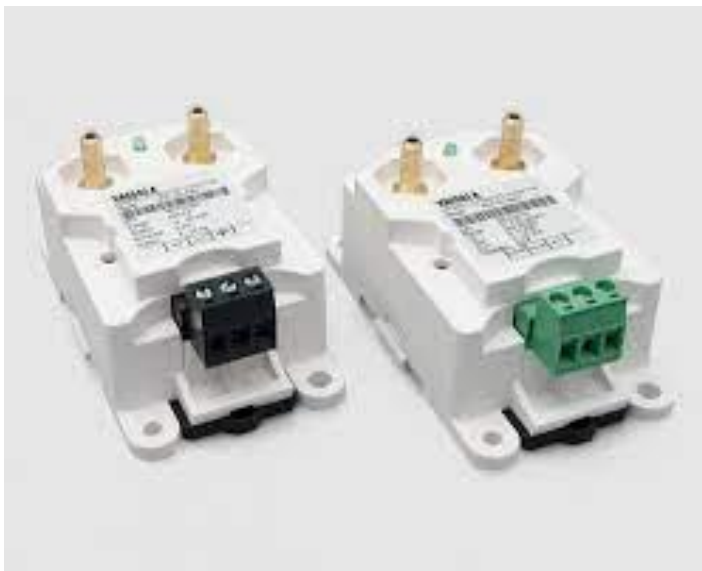
Figure 4 PDT101 [15.]

Vaisala's PDT101 is a differential pressure transmitter. It can measure precise difference between two pressures using its high and low inputs. It is ideal for ViewLinc applications. [8.]

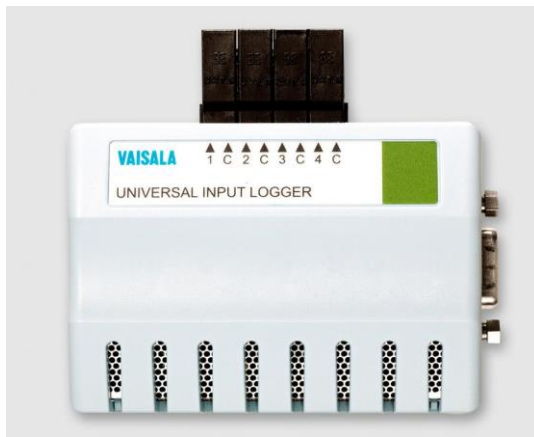
Figure 6 DL4000 [15.]

Vaisala's DL4000 is a data logger which can be connected into ViewLinc through vNet device. This data logger has four channels meaning that four different transmitters can be connected to it. It can provide historical and real-time data. [10.]

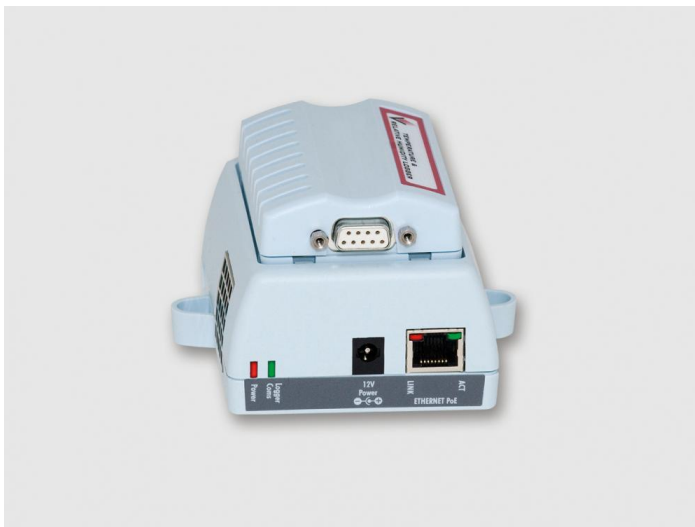
Figure 7 vNet data logger [15.]

Vaisala's vNet PoE data logger interface is a device which can connect DL-series data loggers into ViewLinc through ethernet. [11.]

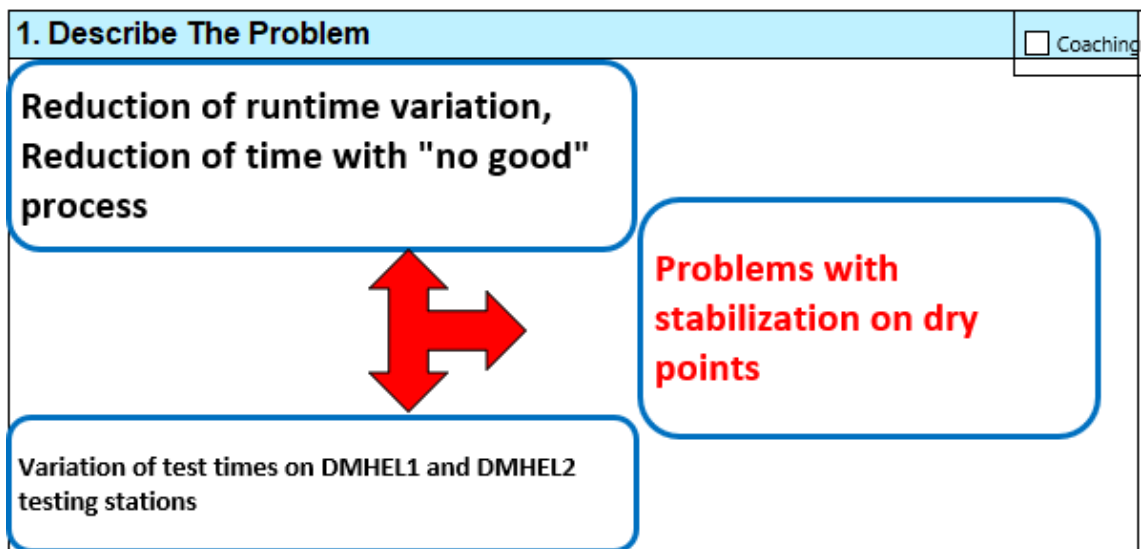
As seen in figure 8, the goal was to improve the yield by reducing the lost run time by fixing the known issues, which were stabilization problems on two frost point calibration points and thus fixing the "current situation".

Figure 8 Part 1 of the A3 approach, Describe The Problem

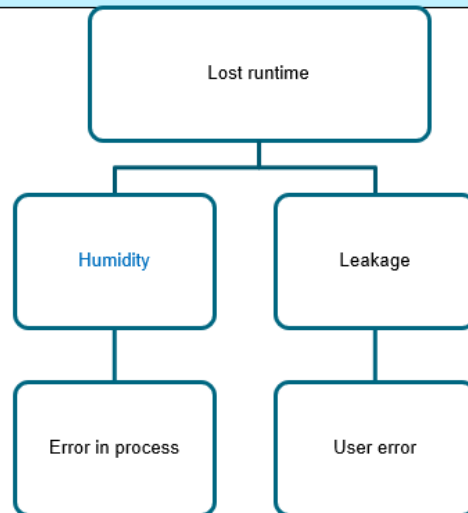
This chapter describes the found root causes of the bad yield. After finding out what causes the problems, a rough division was made to two main causes to simplify the problem. These causes were humidity and leakage, as seen on figure 9.

Figure 9 Part 2 of the A3 approach, Break Down The Problem

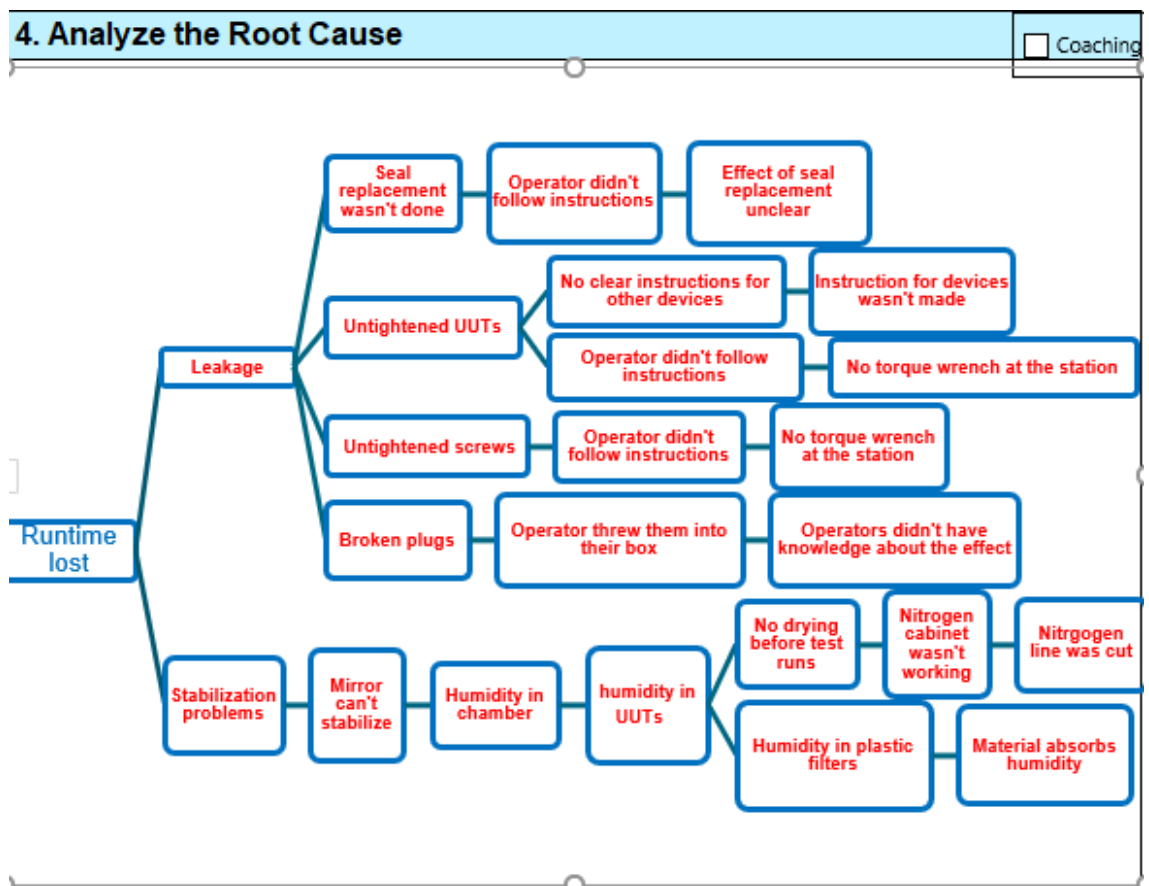
Figure 11 describes the flow chart of the 5 whys with the starting point of two known issues, leakage, and humidity.

Figure 11 Part 4 of the A3 approach, Analyze The Root Cause

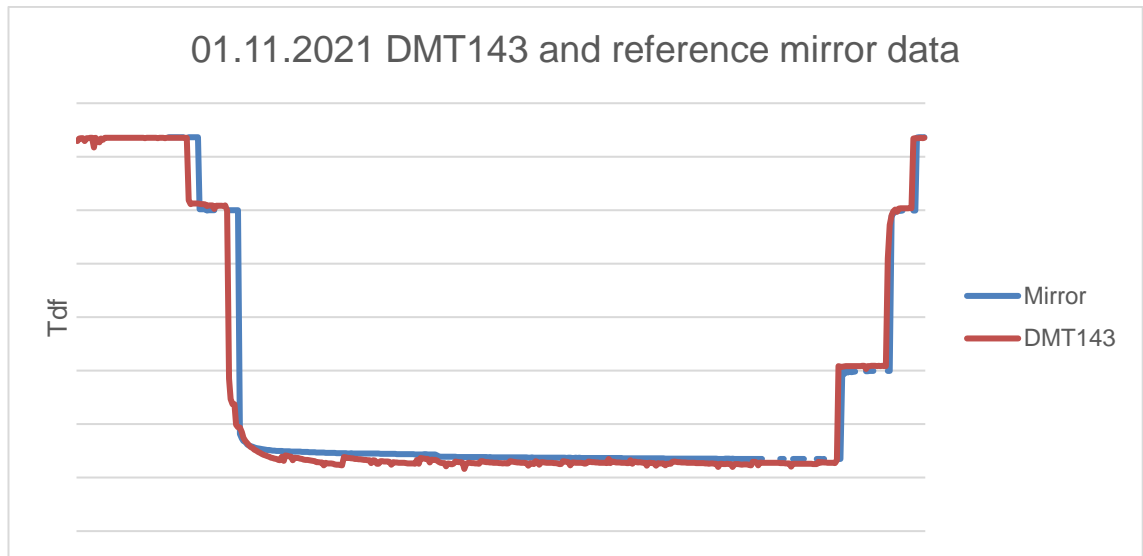
After monitoring the test runs it came clear that UUTs have humidity in them, which caused mirror not being able to stabilize. It was detected by looking the raw dewpoint data from monitoring devices and the mirror, and data suggested

that mirror sees more humidity than the device. Because the measuring system is closed, the humidity must be in UUTs. Figure 12 shows an Excel graph, which was made from the DMT143's and the mirror's data.

Figure 12 Excel graph from ViewLinc and mirror references data

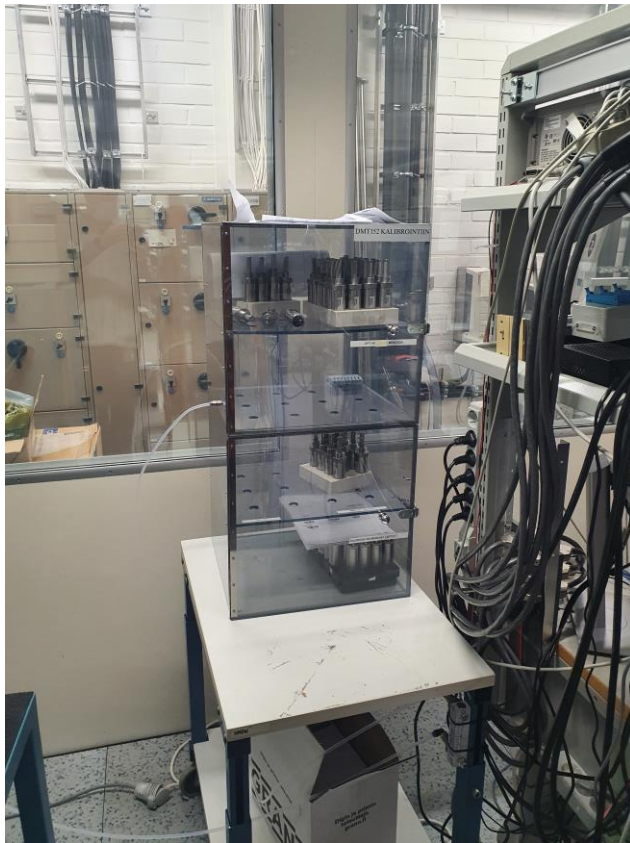
Once the root cause for stabilization problems was found, the devices were placed in a nitrogen cabinet for drying before the test runs. This proved to be very effective, and the test run times including only the devices placed on the cabinet reduced significantly.

Figure 15 Nitrogen cabinet

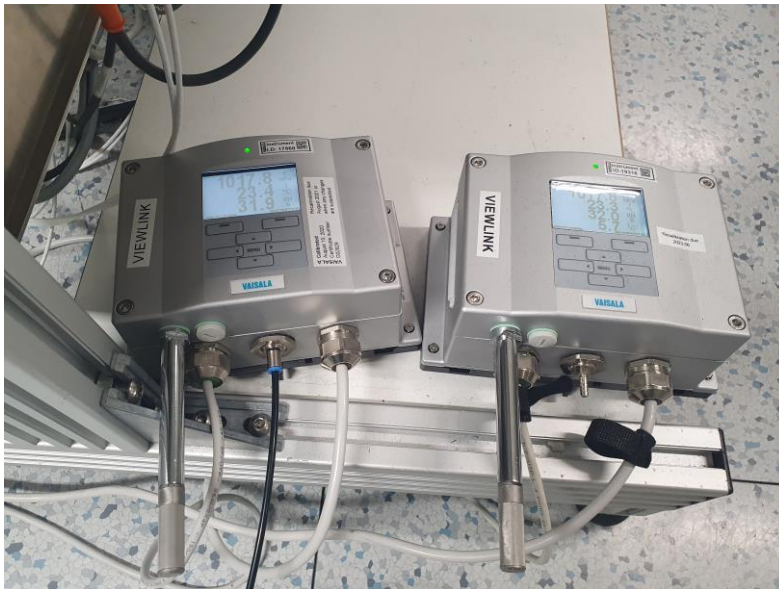
PTU301 was added into ViewLinc, and it was compared with the ambient pressure. Because the measurement chamber is a closed system, it has different pressure than the ambient pressure of the room. If the two pressures are the same, there is leakage on the chamber.

Figure 18 PTU301 devices logging ambient and chamber pressure
