# HYGROTHERMAL CONDITIONS IN CULTURAL INSTITUTIONS IN LITHUANIA AND AUSTRALIA

Bachelor's thesis  
Building Services Engineering

2021

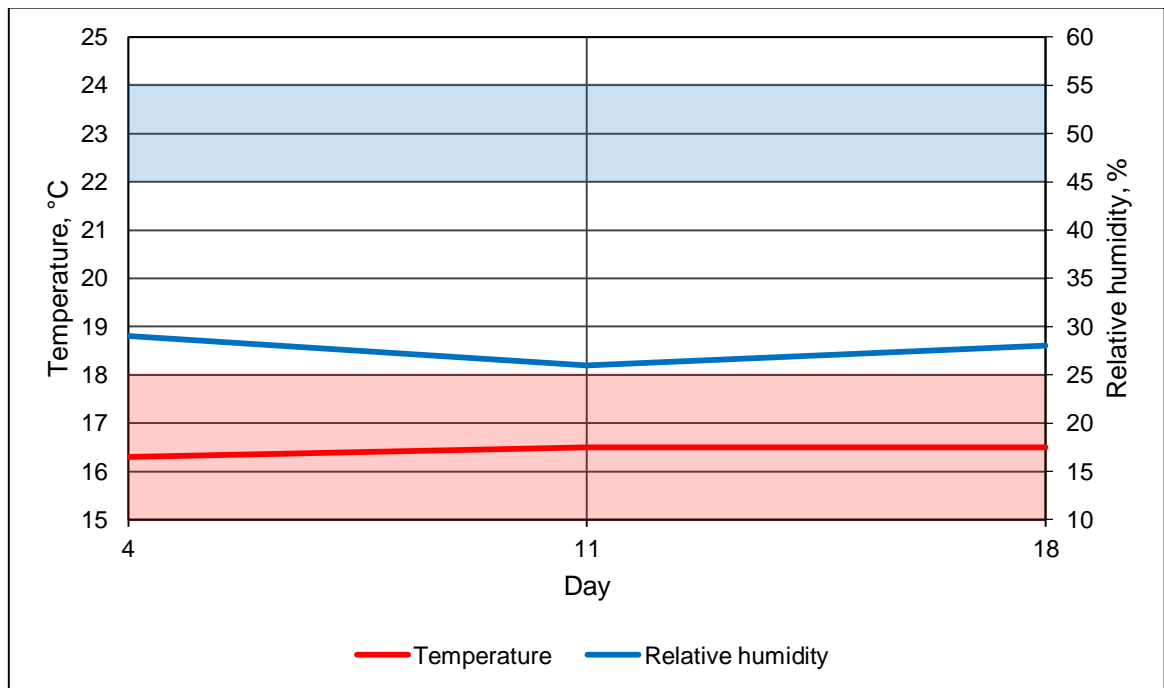
Figure 4. The temperature and relative humidity measurements in February 2019

The average temperature was 16,4 °C, the relative humidity – 28%. As mentioned in the subsection about the systems in the Centre, the temperature should be between 14 °C and 18 °C. During this month, at the times the measurements were taken, the values remained between 16 °C and 17 °C. Therefore, the temperature requirements were met. The relative humidity should remain around 45-55%. As shown in Figure 4, it was in the range from 25% to 30%.

As can be seen in Figure 4, the measurements were only taken three times during February 2019.

The average temperature was 16,6 °C and the relative humidity was 32%. As in the selected months during the previous year (Figures 4 and 5), the temperature once again remained between 16 °C and 17 °C. The relative humidity was 30%, except for the last measurement of the month when it was about 37%. Even though this value was a bit higher, it still did not reach the minimum required value of 45%.

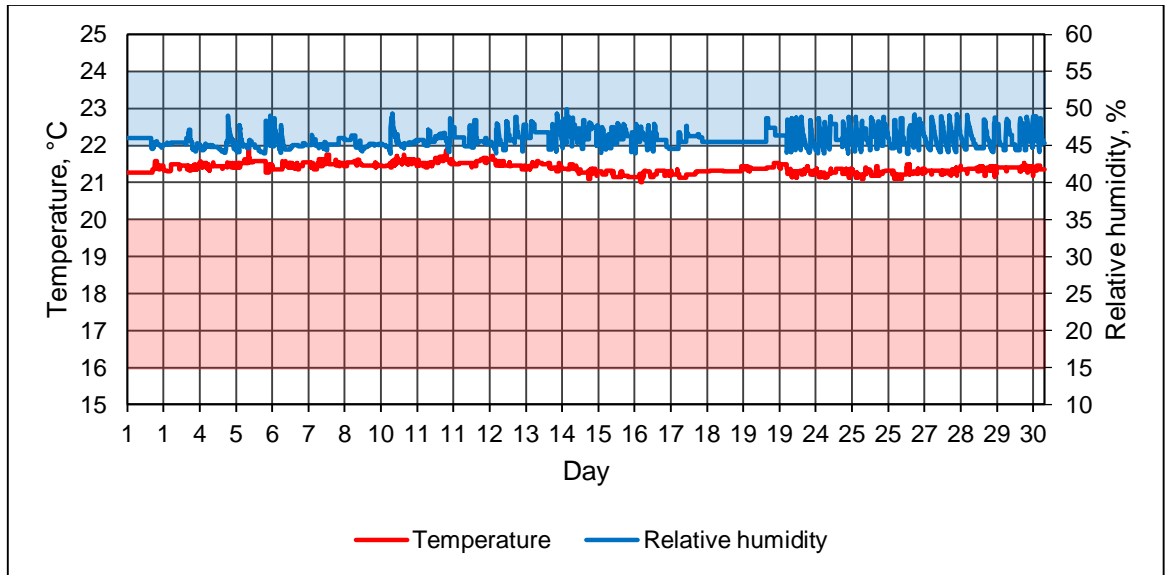
Figure 12. The temperature and relative humidity measurements of the second sensor in the exhibition hall 3

According to the readings of the first sensor, the average temperature was 21,8 °C. Most of the time, it was in the range from about 21,5 °C to about 22,5 °C. On average, there was 45% of relative humidity. The relative humidity was between 43% and 48% for the most part. The lowest point was around 36%. Based on the readings of the second sensor, the average temperature was 21,3 °C, the relative humidity – 46%. The values ranged from 21 °C to 22 °C, the relative humidity – from 44% to 49%. Generally, both sensors showed similar results. As in both previous exhibition halls, the temperature is above 20 °C. The relative humidity almost meets the requirements.

As stated in the subsection containing the information about the systems, there are two sensors in the exhibition hall 3. As can be seen from figures 11 and 12, there are slight differences in the readings of both sensors.

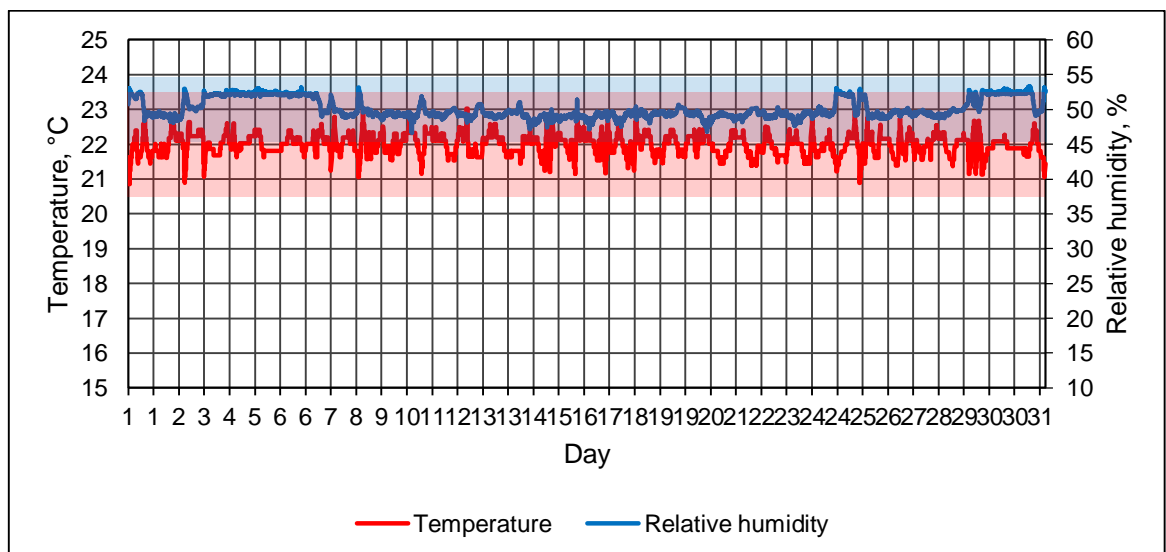
Figure 16. The temperature and relative humidity measurements in the gallery in March 2020

The temperature varied between 20,9 °C and 22,9 °C. Its average value was 21,5 °C. The relative humidity was in the range from 47% to 54%, the average value was 52%. Once again, the hygrothermal conditions remained within the limits.

The readings in the gallery during March 2020 are shown in Figure 16.
