Ensuring the reliability of bridge structures

Study material for bridge design course

LAB University of Applied Sciences

2022

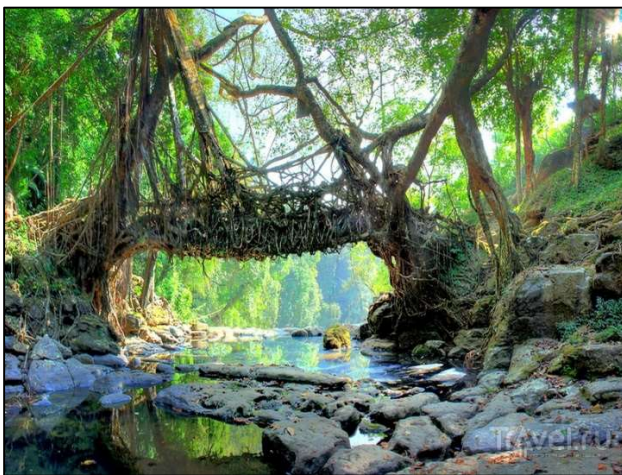
At the same time, plexus of tree branches hanging over rivers, prompted the people of the ancient India to create “live” suspension bridges weaving roots of rubber plant (Image 1).

Image 1. “live” suspension bridge in India (Image: Rohit Mordani)

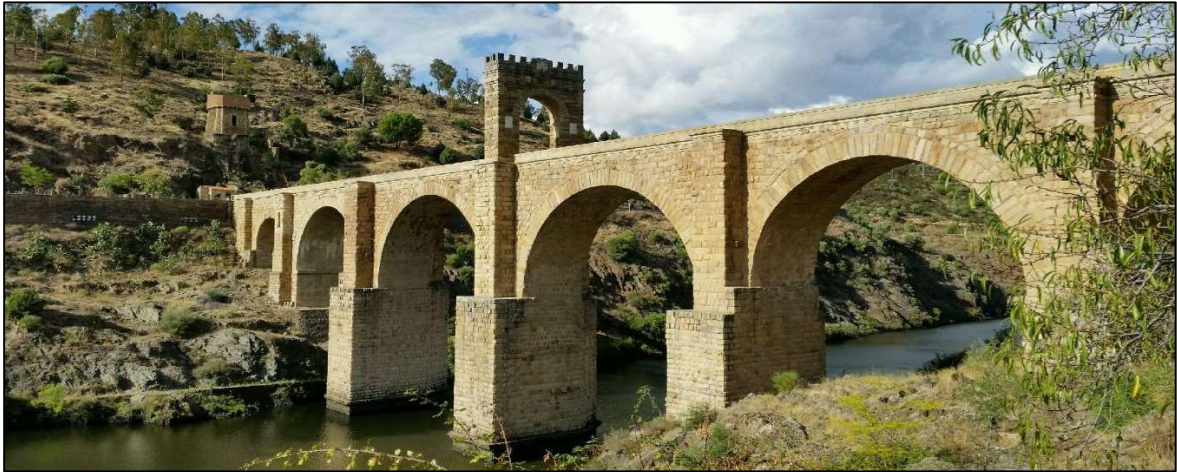
One of the surviving Roman bridges is the Alcantara Bridge in modern Spain. This bridge was built in 104-106 CE and have an arches, each spanning 29 metres (Image 2) (Billington).

Image 2. Alcantara Bridge (Image: Salta Conmigo)

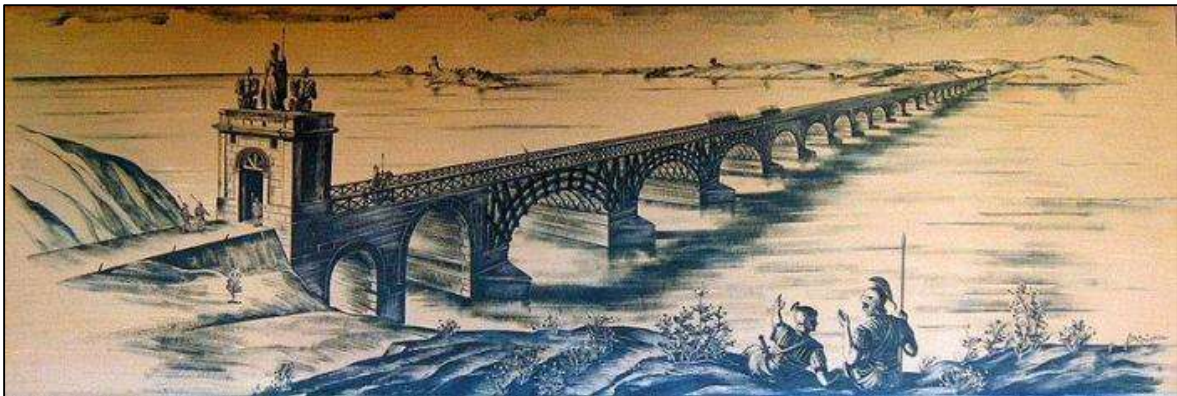
At the same time the first bridge over the Danube River was built by the ancient Greek builder Apollodorus of Damascus during Trajan campaign against the Dacians in 104. It had 20 stone supports with high of 46 m and about 18 m wide. Spans were 35 m long and were covered with wooden arches made up of three rows of beams (Image 3). The remains of the pillars of this bridge have survived to our time. (Kalmikov 1957, 18.)

Image 3. Bridge of Apollodorus over the Danube (Image: U. Rapsak)

The Bridge of Apollodorus with wooden arch spans illustrate a big step in developing of bridge structures, by gathering best solutions of previous structures. Girder wooden bridges can cover spans only up to 14-16 meters, so to build a girder bridge over the Danube, at least twice more supports required and reached the number of 40. In addition, wooden supports in the zone of variable water level do not last long. A stone bridge with similar spans would be too high because of circular-arched form, heavy and difficult to build. So, antique engineer decided to use stone only in supports, replacing it from arched spans by a material capable to work for bending, and got fundamentally new structure. This case demonstrate the process how structures were evolving from ancient times to the present day.

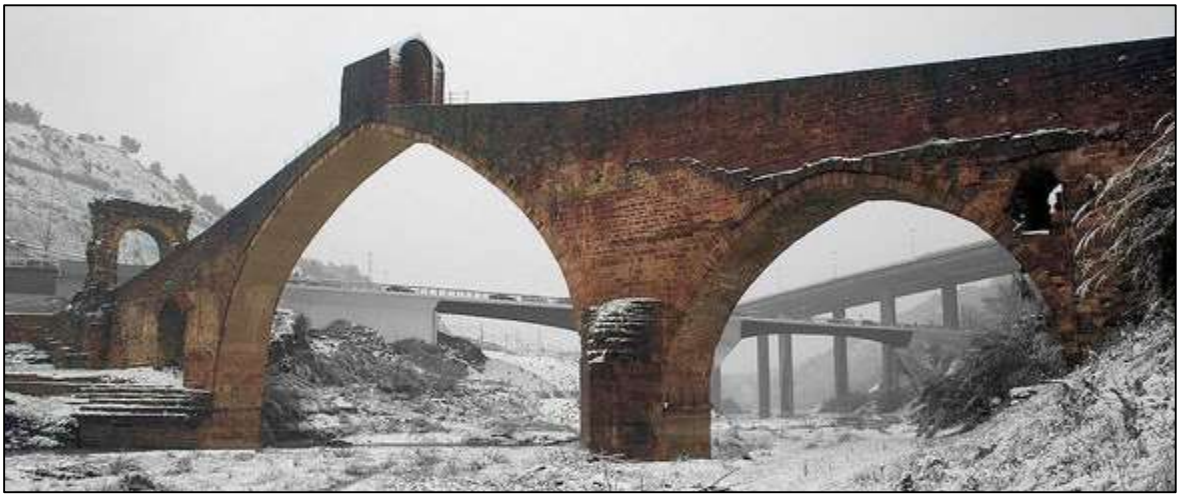
The era of stone and wooden bridges continued after the fall of the Roman Empire for many centuries. In the construction of bridges, nothing significantly changed until the 19th century. However, they had some peculiarities. It is worth noting, that the shape of arches in that time were modified to ogival, or pointed arch, which reduced the risk of sagging at the crown of an arch and decrease horizontal force at the abutments. (Billington.) One of these bridges is Pont del Diable in Spain, which was built in 1283 year (Image 4). The main span of bridge is 37.3 m.

Image 4. Pont del Diable (Image: Sansar)

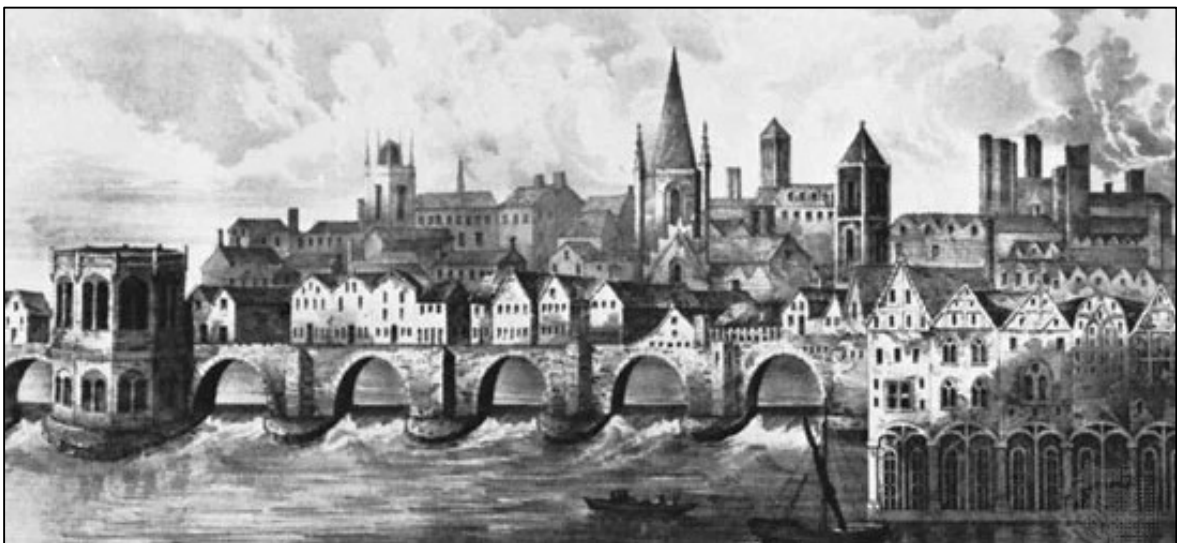
Another feature of medieval bridges was that towers, houses or shops were often built on them. The most illustrative bridge of that was Old London Bridge, completed in 1209 (Image 5).

Image 5. Old London Bridge (Encyclopedia Britannica)

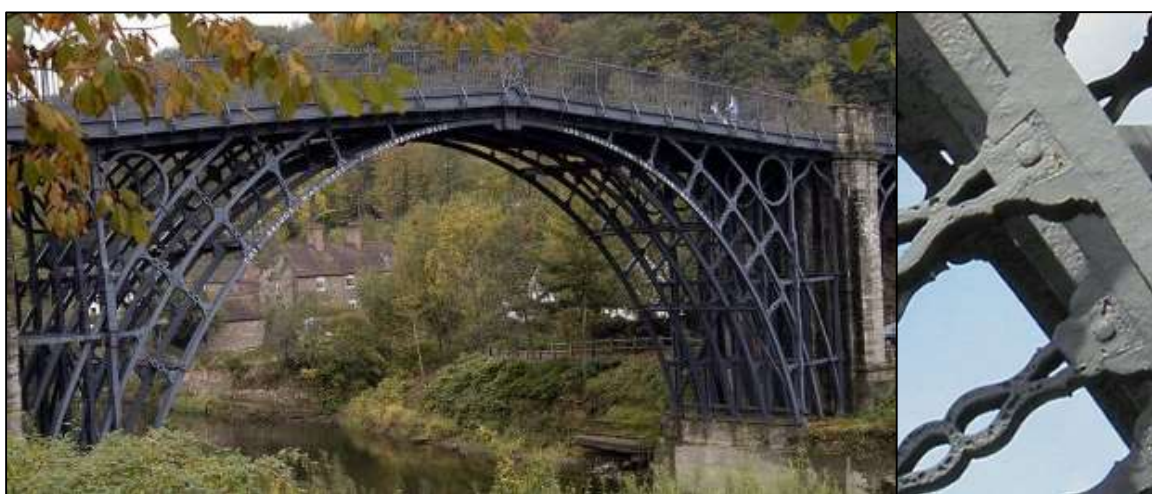
The turning point for bridge building was the industrial revolution, which made metal an affordable building material. At first it was cast iron. It can be said that cast iron made it possible to combine the advantages of stone and wooden structures, taking strength from the first and delicacy from the second. As a result, the dead load on the structure was significantly reduced. The first bridge made of cast iron was built in 1779 by Abraham Darby in England and have a 30 meters span (Image 8) (Johnson). Since cast iron has low tensile strength, the bridge was made arched, like a stone one and the joints between elements were made same as they were made in timber structures (Image 9, right part), which again, illustrates the mentioned principle of the evolution of bridge structures and their succession.

Image 8. Ironbridge (Johnson)

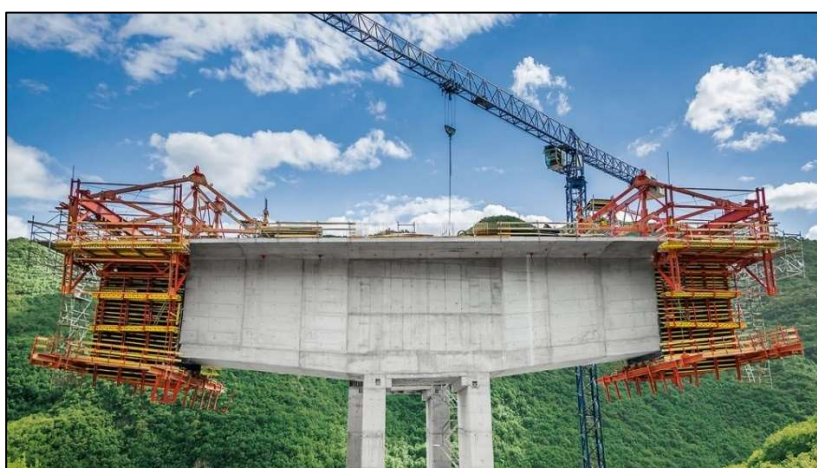
Image 9. Balanced concreting technology (PERI)

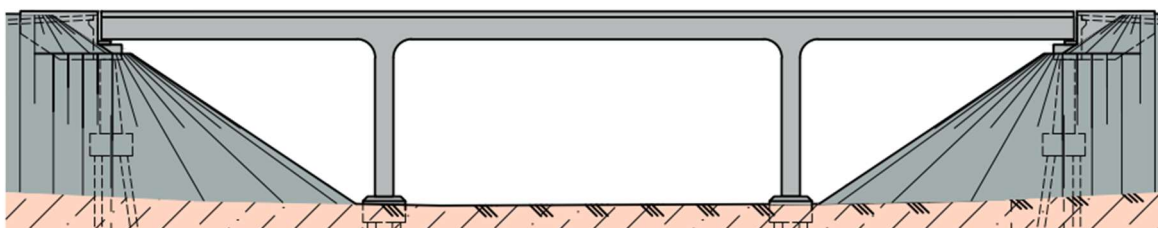
Figure 10. Continuous rigid-frame bridge

Figure 10 shows a rigid-frame bridge without internal hinges. This solution leads to appearance of bending moment in the middle of span, opposite to the first case, but the value is less than in continuous bridges. But because of high index of static indeterminacy such bridges can be built only on reliable soils and have no more than 3 spans to avoid high extra forces from thermal expansion.

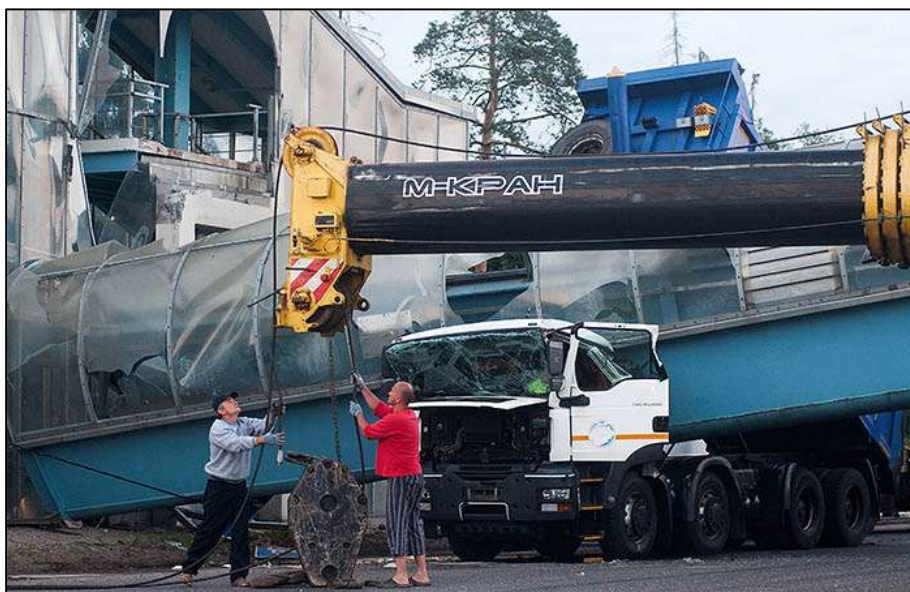
There are many cases of bridge collapse due to the collision of dump trucks with a raised body: the overpass near Orenburg (Karavanskiy 2015), the pedestrian bridge on the road M-10 (Image 10) (Interfax 2016), the pedestrian bridge on the road P-242 (Dorinfo 2022), the overpass in Pavlodar region, Kazakhstan (Tengrinews 2019), the pedestrian bridge in Helsinki (Yle 2010), the overpass above Georgia's I-16, USA (@GDOT East Traffic 2021) and others.

Image 10. Pedestrian bridge collapse on the road M-10 (Interfax 2016)

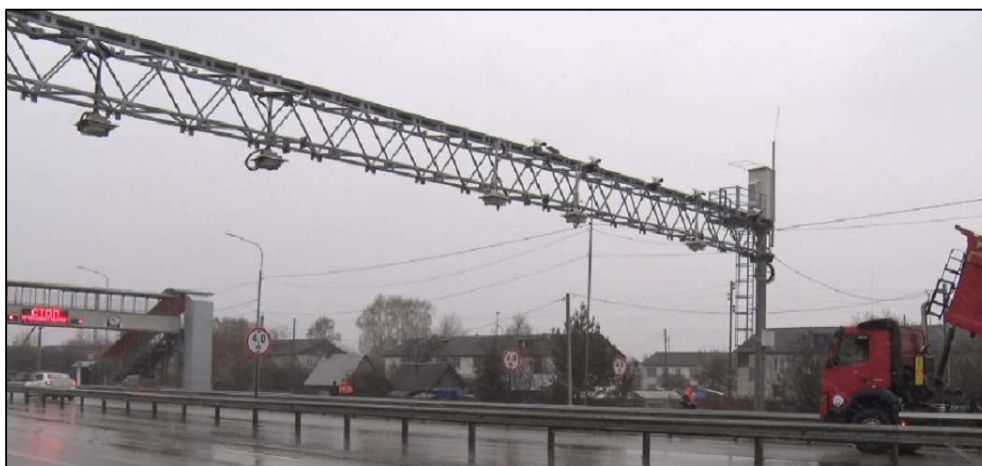
Image 11. laser clearance gate system

Since in such cases, the driver of a dump truck or truck crane does not know about the raised body or boom, despite the presence of warning systems in modern machines, to prevent such incidents an installation of laser clearance gates is looks like a good solution. At present, such systems are not widely used; at the moment, two cases of application have been found: in Ottawa city, Canada (Telegram 2014) and near Tumen city, Russia (Ural-meridian 2020) (Image 11).

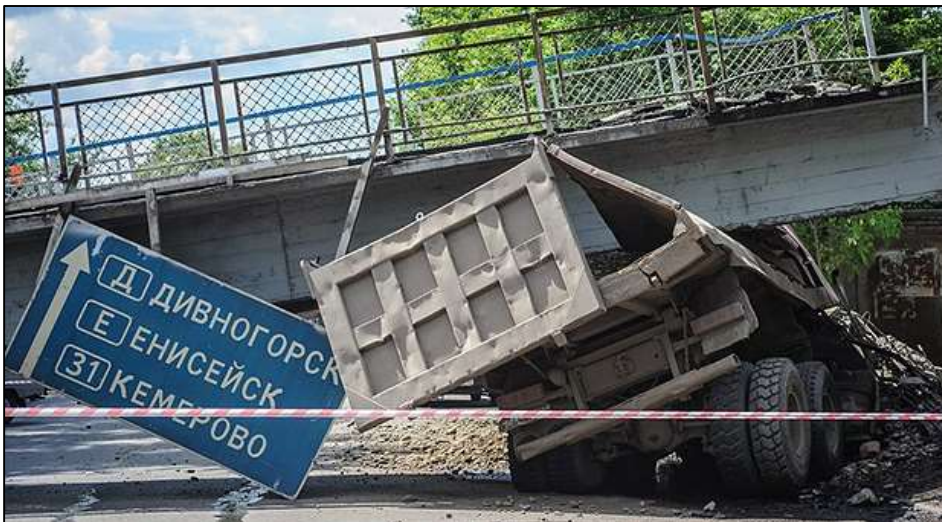
Another common type of accidental actions caused by road vehicles and ships is collision with pillars. The examples are overpass collapse in Ekaterenburg, Russia (Interfax 2011), the collapse of pedestrian bridge in Krasnoyarsk, Russia (Dela.ru 2014) (Image 12) and the largest accident of this type - I-40 bridge disaster in 2002, Oklahoma, United States (E

Image 12. the collapse of pedestrian bridge in Krasnoyarsk, Russia (Dela.ru 2014)

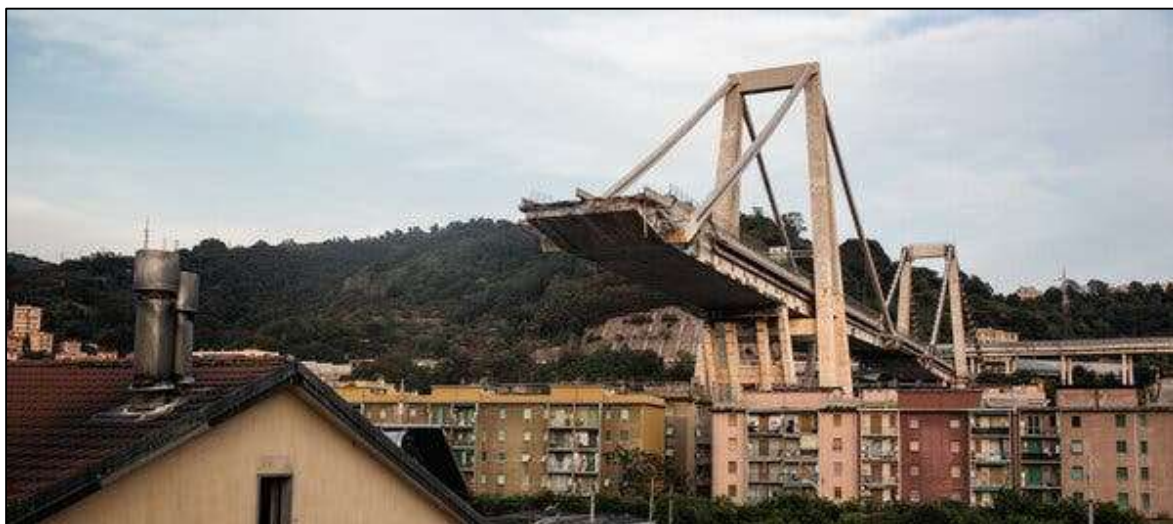
Image 14. Collapsed Morandi Bridge (Image: Nadia Shira Cohen)

A significant part of bridge collapses occurs due to untimely detection and elimination of critical structural defects. One of the recent and most famous cases is the collapse of Morandi bridge in Italy on 14 August 2018 (Image 14).

What exactly caused the collapse is still unknown, but experts found an evidence of corrosion of stay cables. In the case of Morandi Bridge the cables were difficult to inspect, since they were covered with concrete. (Mattioli 2019).

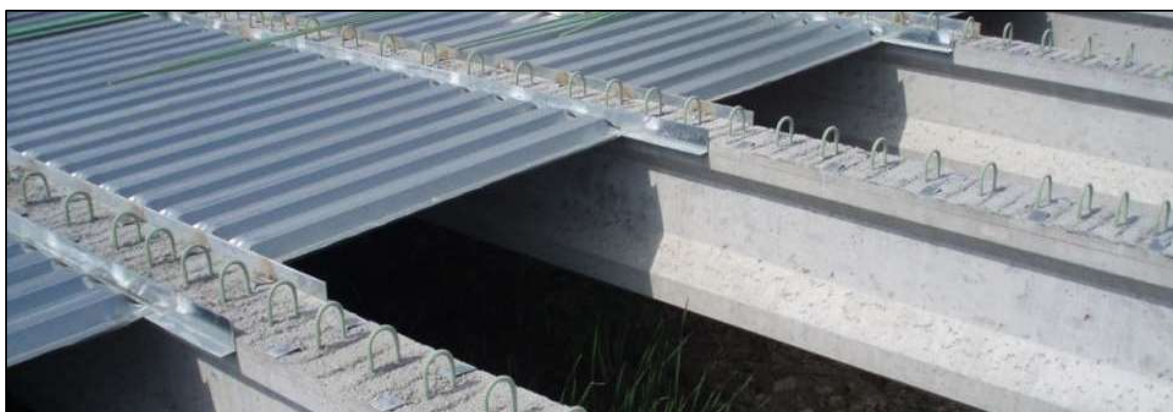
Image 15. leave-in-place form (Image: Inventure Holdings)

Although prestressed concrete stays are not currently used in new bridges, this case shows that all load-bearing elements of structure must be available for inspection and repair. However, there are some solutions common in modern practice contradicts this requirement. For example, such solution is leave-in-place form (Image 15), that is widely used in composite-girder bridges.

Leave-in-place form greatly simplifies slab concreting, but in case of waterproofing damage, it, firstly, contributes to the accumulation of water in concrete, and secondly, hides the fact and place of leakage, that leads to extensive corrosion of reinforcement and shear connectors (Syrkov 2021) (Figure 18). Shear connectors are small but very important elements of composite-girder bridges since they provide connection between concrete slab and steel beam to make them work as parts of one section, that is way corrosion of this elements leads to significant reduction in bearing capacity of superstructure.

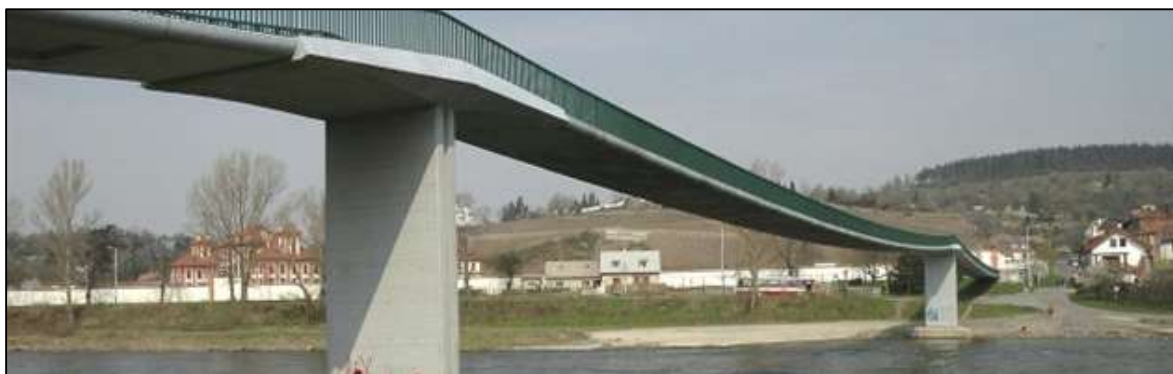
Another relevant example of failure due to the degradation of the hidden main load-bearing elements is collapse of Troja footbridge in Prague in 2017 (Image 16).

Image 16. Troja footbridge in Prague (Image: StrawberryLab)

The fact that the condition of the bridge was a cause for concern was known long before the tragedy, that is why the bridge was electronically monitored in real time since 2013, but it did not help to prevent the collapse (Lazarova 2017). In stress ribbon bridge the main load bearing elements are prestressed steel cables, usually located into or under deck slab. The most probable cause of the collapse is the corrosion of these cables, which were not available for inspection since they were placed into concrete deck (Image 17).

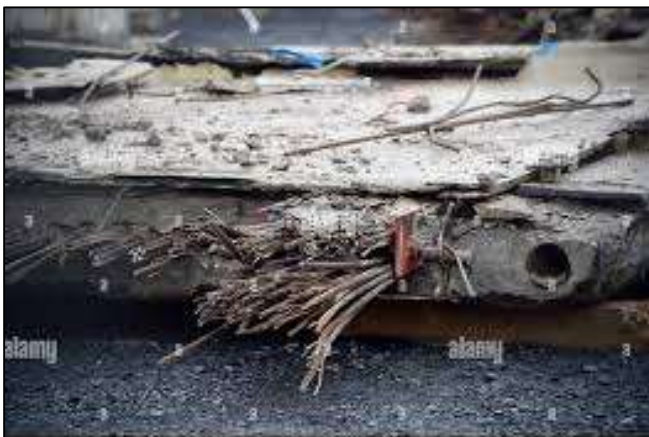
Image 17. The deck of Troja footbridge after collapse (Image: Vit Simanek)

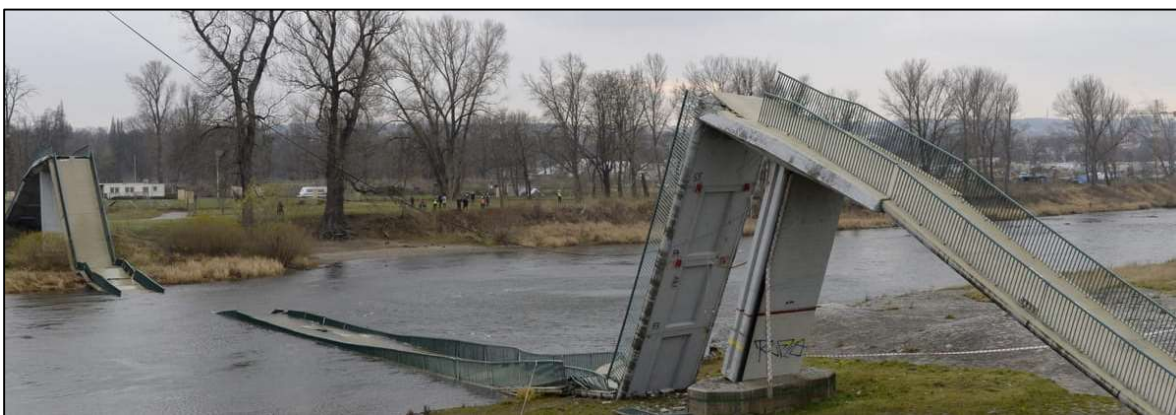
In fairness, it should be noted that for prestressed concrete structures the internal location of tendons is normal and rarely causes problems in case of proper provision of crack resistance. But the thin section deck of stress ribbon bridge has quite small stiffness, that make them not resistant against cracks enough. The presence of cracks reaching the reinforcement guarantees corrosion, since it provides contact of steel with atmospheric air. It seems that in the case of Troja footbridge, cracks appeared in the deck and led to corrosion, which was accelerated by use of anti-icing agents mentioned by professor Strasky in the process of litigation (Mizzy 2022). It should be noted that the corrosion of prestressed reinforcement is especially dangerous, since when the tensioned wire cross section is reduced to a critical size, it breaks sharply, but not slow fluidity, as in the case with non-prestressed reinforcement. This fact raises doubts about the correct choice of the monitoring system, the function of which was to measure structure deflection. The inability of such system to detect signs of an impending collapse is confirmed by the fact that immediately before the collapse, the magnitude of the deflection was normal (Lazarova 2017).

Image 18. The Troja footbridge after collapse

The district court stated that the project of Troja footbridge was flawless (Mizzy 2022) and there are no objective grounds to say that this is not so, because probably with proper maintenance and operation the collapse would not have happened, but seems that main design solution cannot be said to be reliable, because it did not allow assessing the condition of the tendons and led to instant collapse caused by undesirable but possible deviation from service conditions.

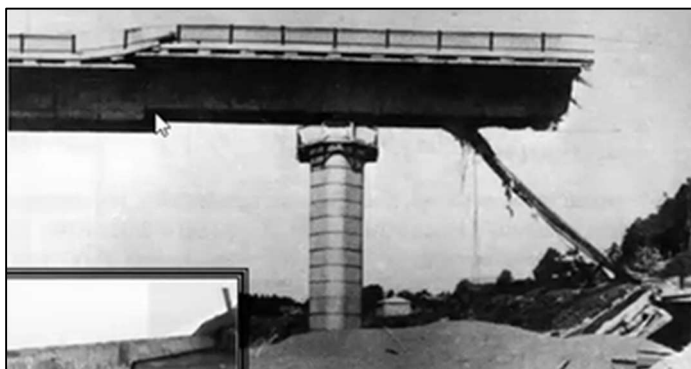
Image 19. The collapse of the bridge over Suhona river (Syrkov 2021)

However, if the destruction occurs in the superstructure, then the progressive collapse can be prevented. For example, in 1986 a 63-meter span of continuous prestressed concrete bridge over Suhona river in USSR collapsed due to corrosion of tendons (Syrkov 2021) (Image 19), but despite the elimination of the unloading effect of adjacent span and redistribution of efforts, collapse did not spread to other spans. Later the collapsed span was replaced by metal simple-supported girder. (Image 20)

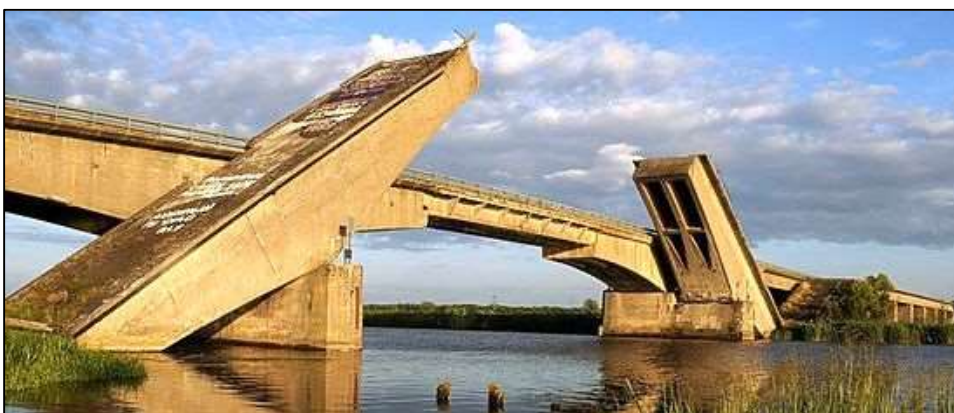
Image 21. Collapsed Palmburger bridge in Kaliningrad (Image: Rybakov Andrey)

However, not only statically indeterminate systems are subject to progressive collapse, but also statically determinate, especially cantilever systems, as shown in figure 21 and image 21.

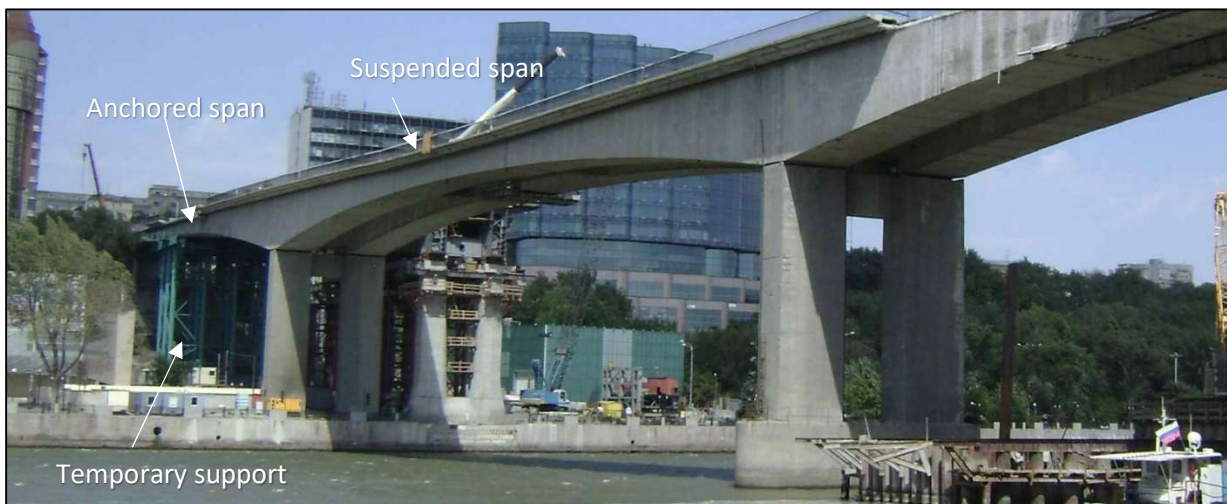
A similar incident could have happened in Rostov-on-Don in 2007 due to rupture of 28 tendons of anchor span, but the defect was detected during the inspection and temporary support was installed to prevent a collapse (Image 20). It is also worth noting that the collapse did not happen since the span consisted of two parallel beams, and undamaged one took an extra load on itself (Syrkov 2021). Such mechanism of behavior of structure in case of local failure rather reflects the robustness, which will be discussed in next subsection.

Image 20. Old Voroshilovskiy bridge in Rostov-on-Don (adapted from T.K.M.)

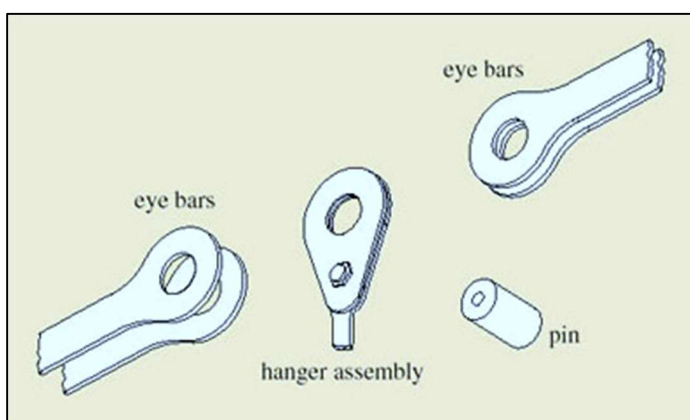
Figure 22. Structure of critical eye-bar joint (The Open University)

These chains consisted of eye-bars connected by pins as shown in image 22.

Investigation concluded that the collapse initially caused by a small stress crack, around three millimeters deep, inside the bearing loop of eyebar 330. The crack had grown around an impurity in the steel and had been aggravated by the elements and the natural movements of the eyebar along the pin over the 39 years of the bridge's use. (Reimann, 2017). Thus, after the destruction of the eye-bar joint, the load-bearing chain instantly lost its bearing capacity and the bridge collapsed.
