Restoration Crafts and Practises at Seidla Manor in Estonia

—Sustainable Heritage Report No. 2

Novia Publications and Productions,
series S: Student Works, 3/2012

A joint project between Gotland University, Estonian Academy of Arts
and Novia University of Applied Sciences.

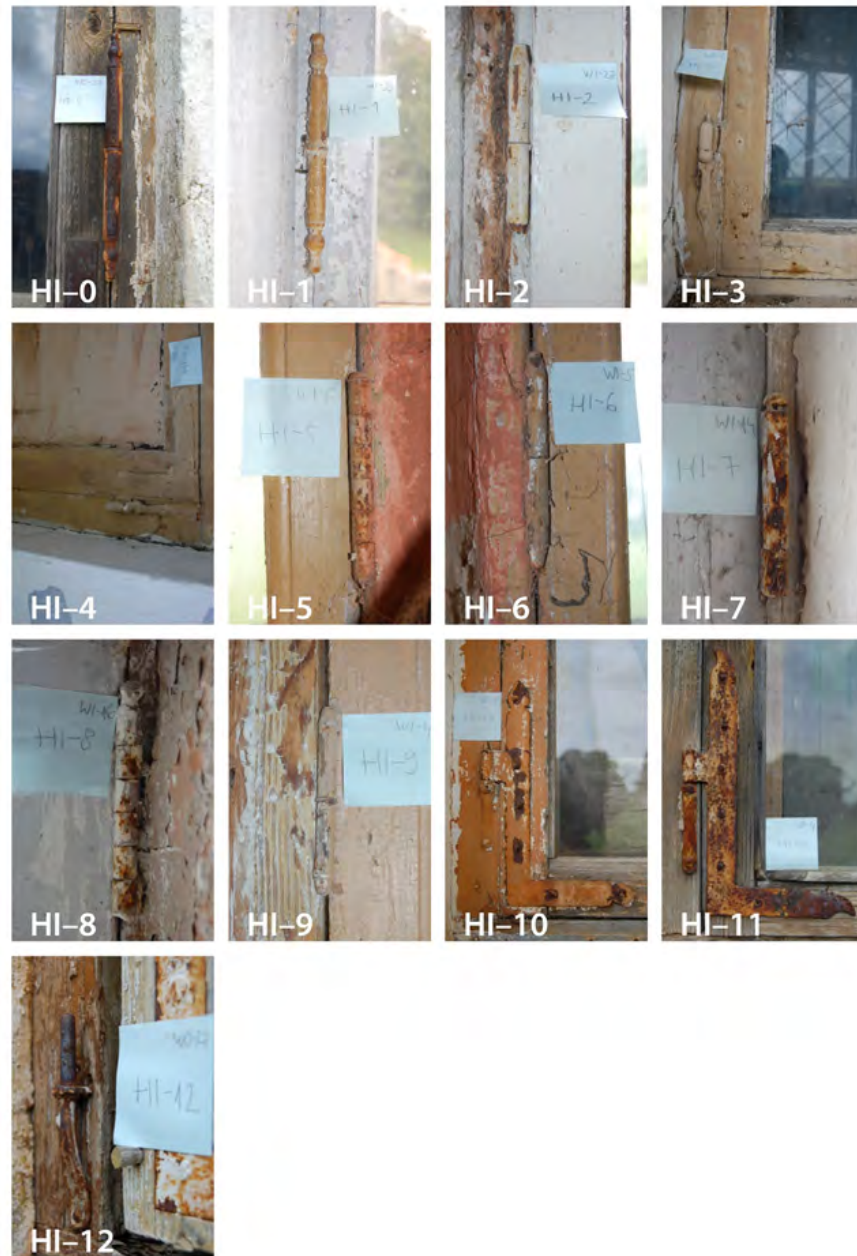
Figure 1.8 a. Hinges: HI-(0-12).

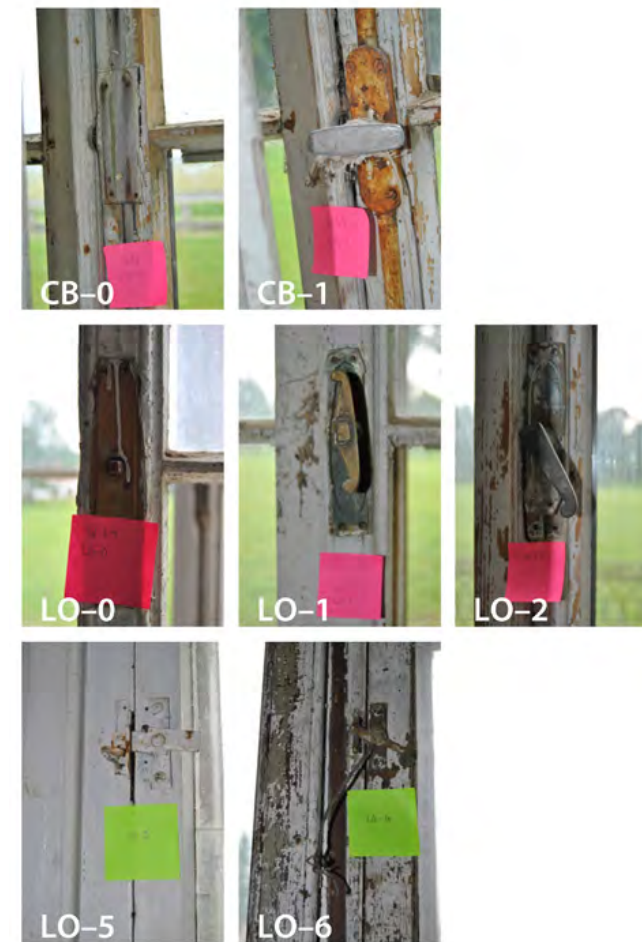
Figure 1.8 b. Cremonese bolts and locks: CB-(0-1) and LO-(0-2), LO-(5-6).

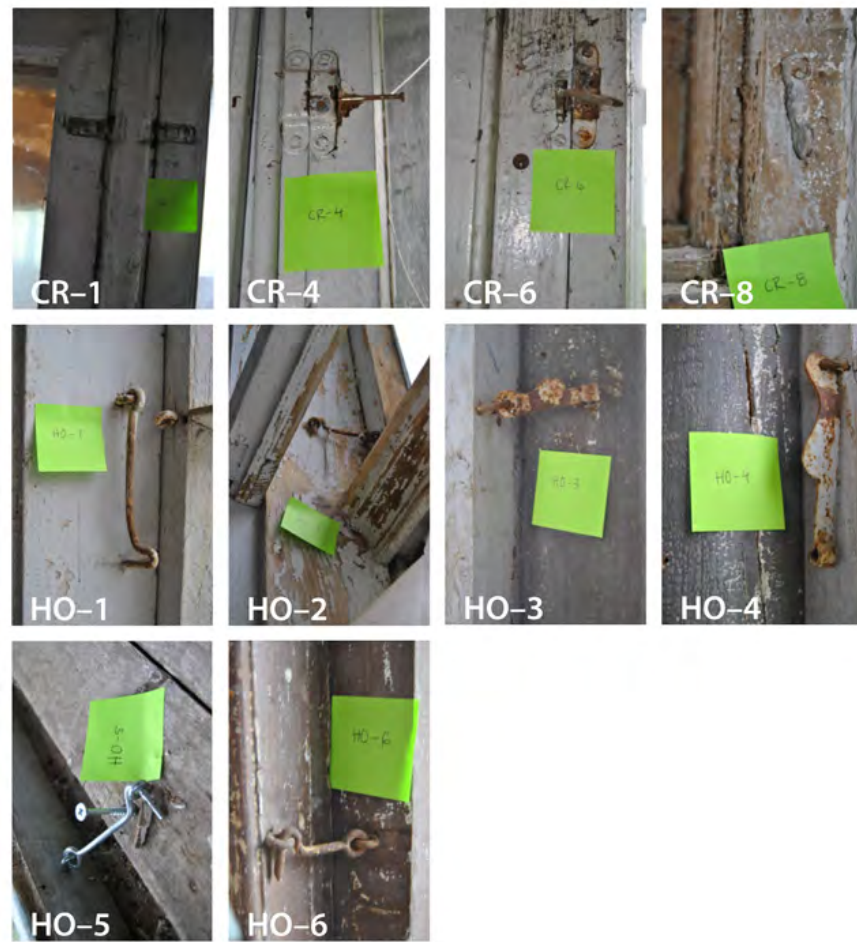
Figure 1.8 c. Cranks and hooks: CR-(1-3) and HO-(1-6).

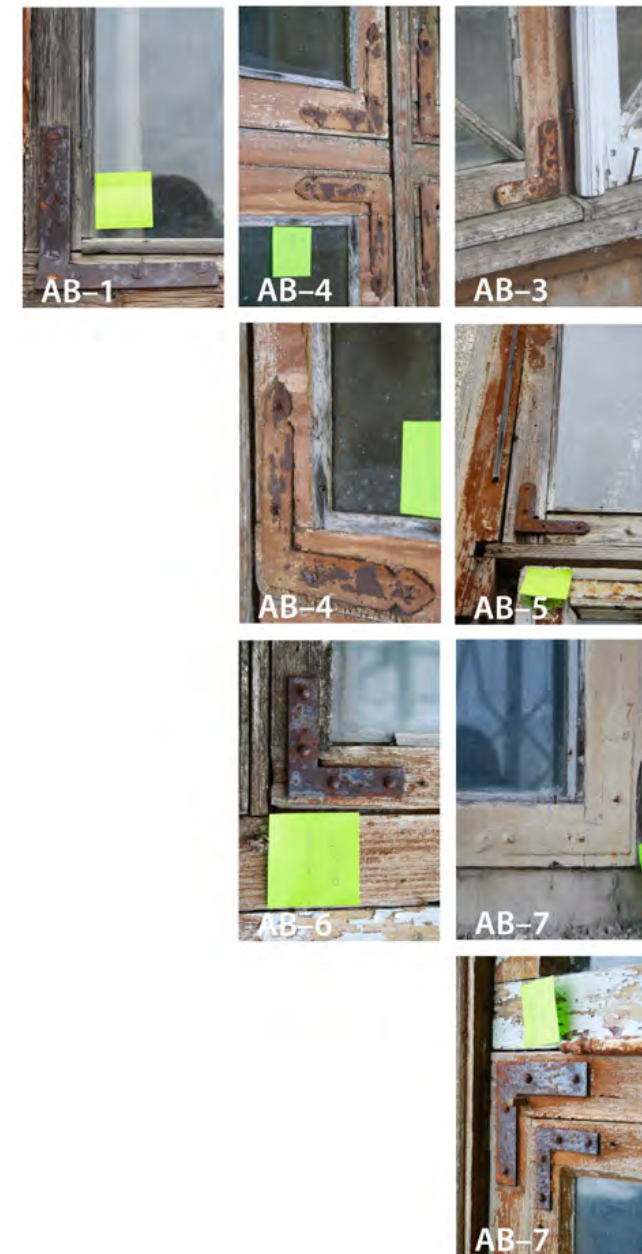
Figure 1.8 d. Angel bars: AB-(1-8).

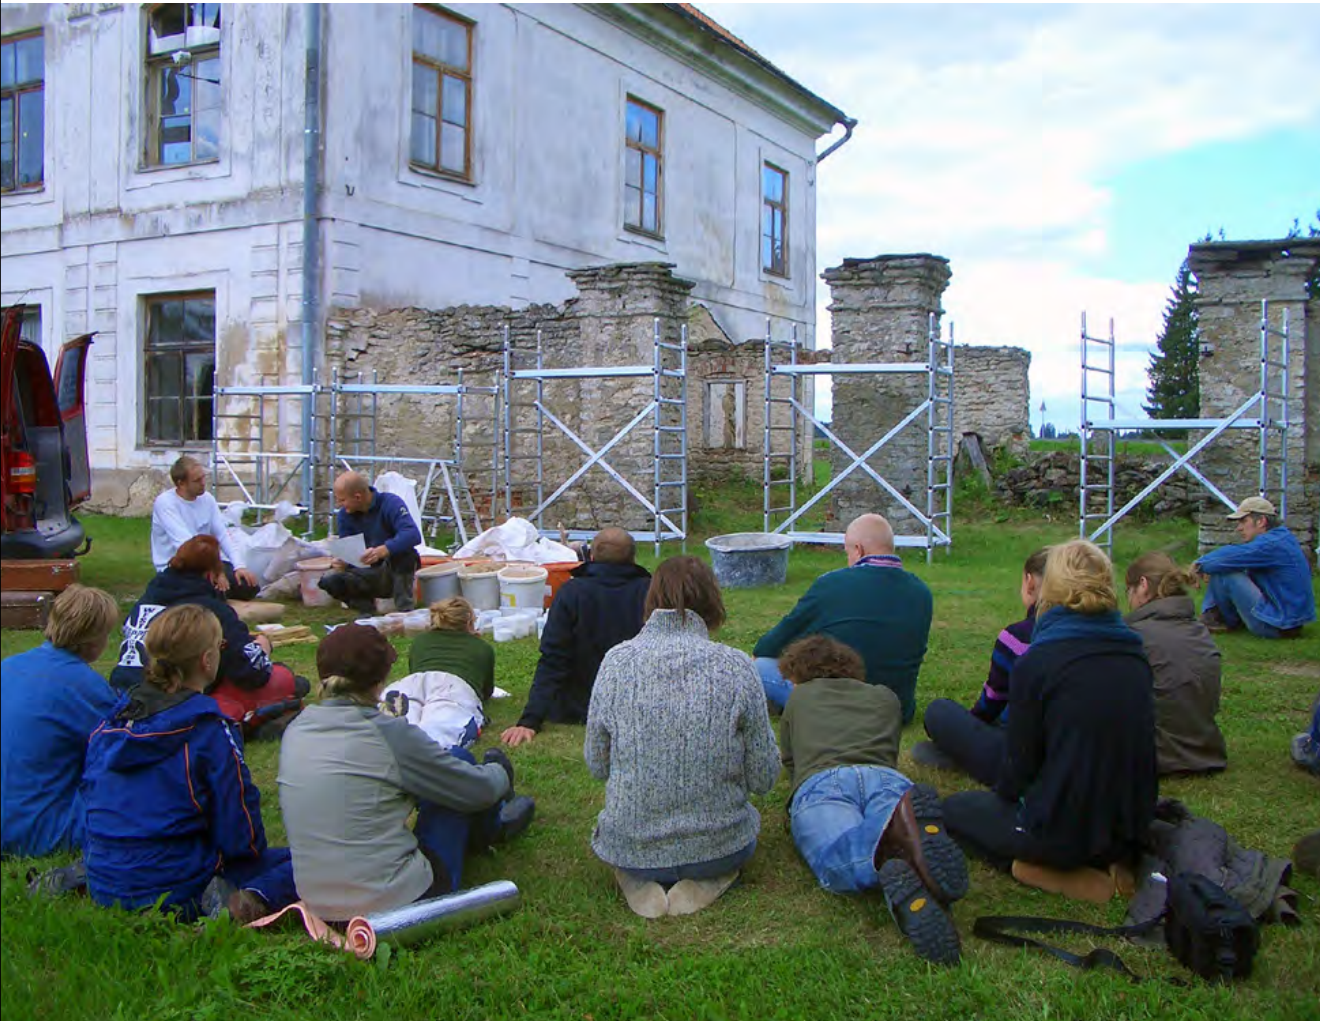
Figure 2.1. Students learning about mortars and restoration of stone walls. Teachers Taavi Leis (left) and Kermo Jürmann introduce correct materials and tools. Gateposts which are to be restored stand in the background waiting for their restorers. From left: gatepost A (Swedish students), B (Finnish students) and C (Estonian students).

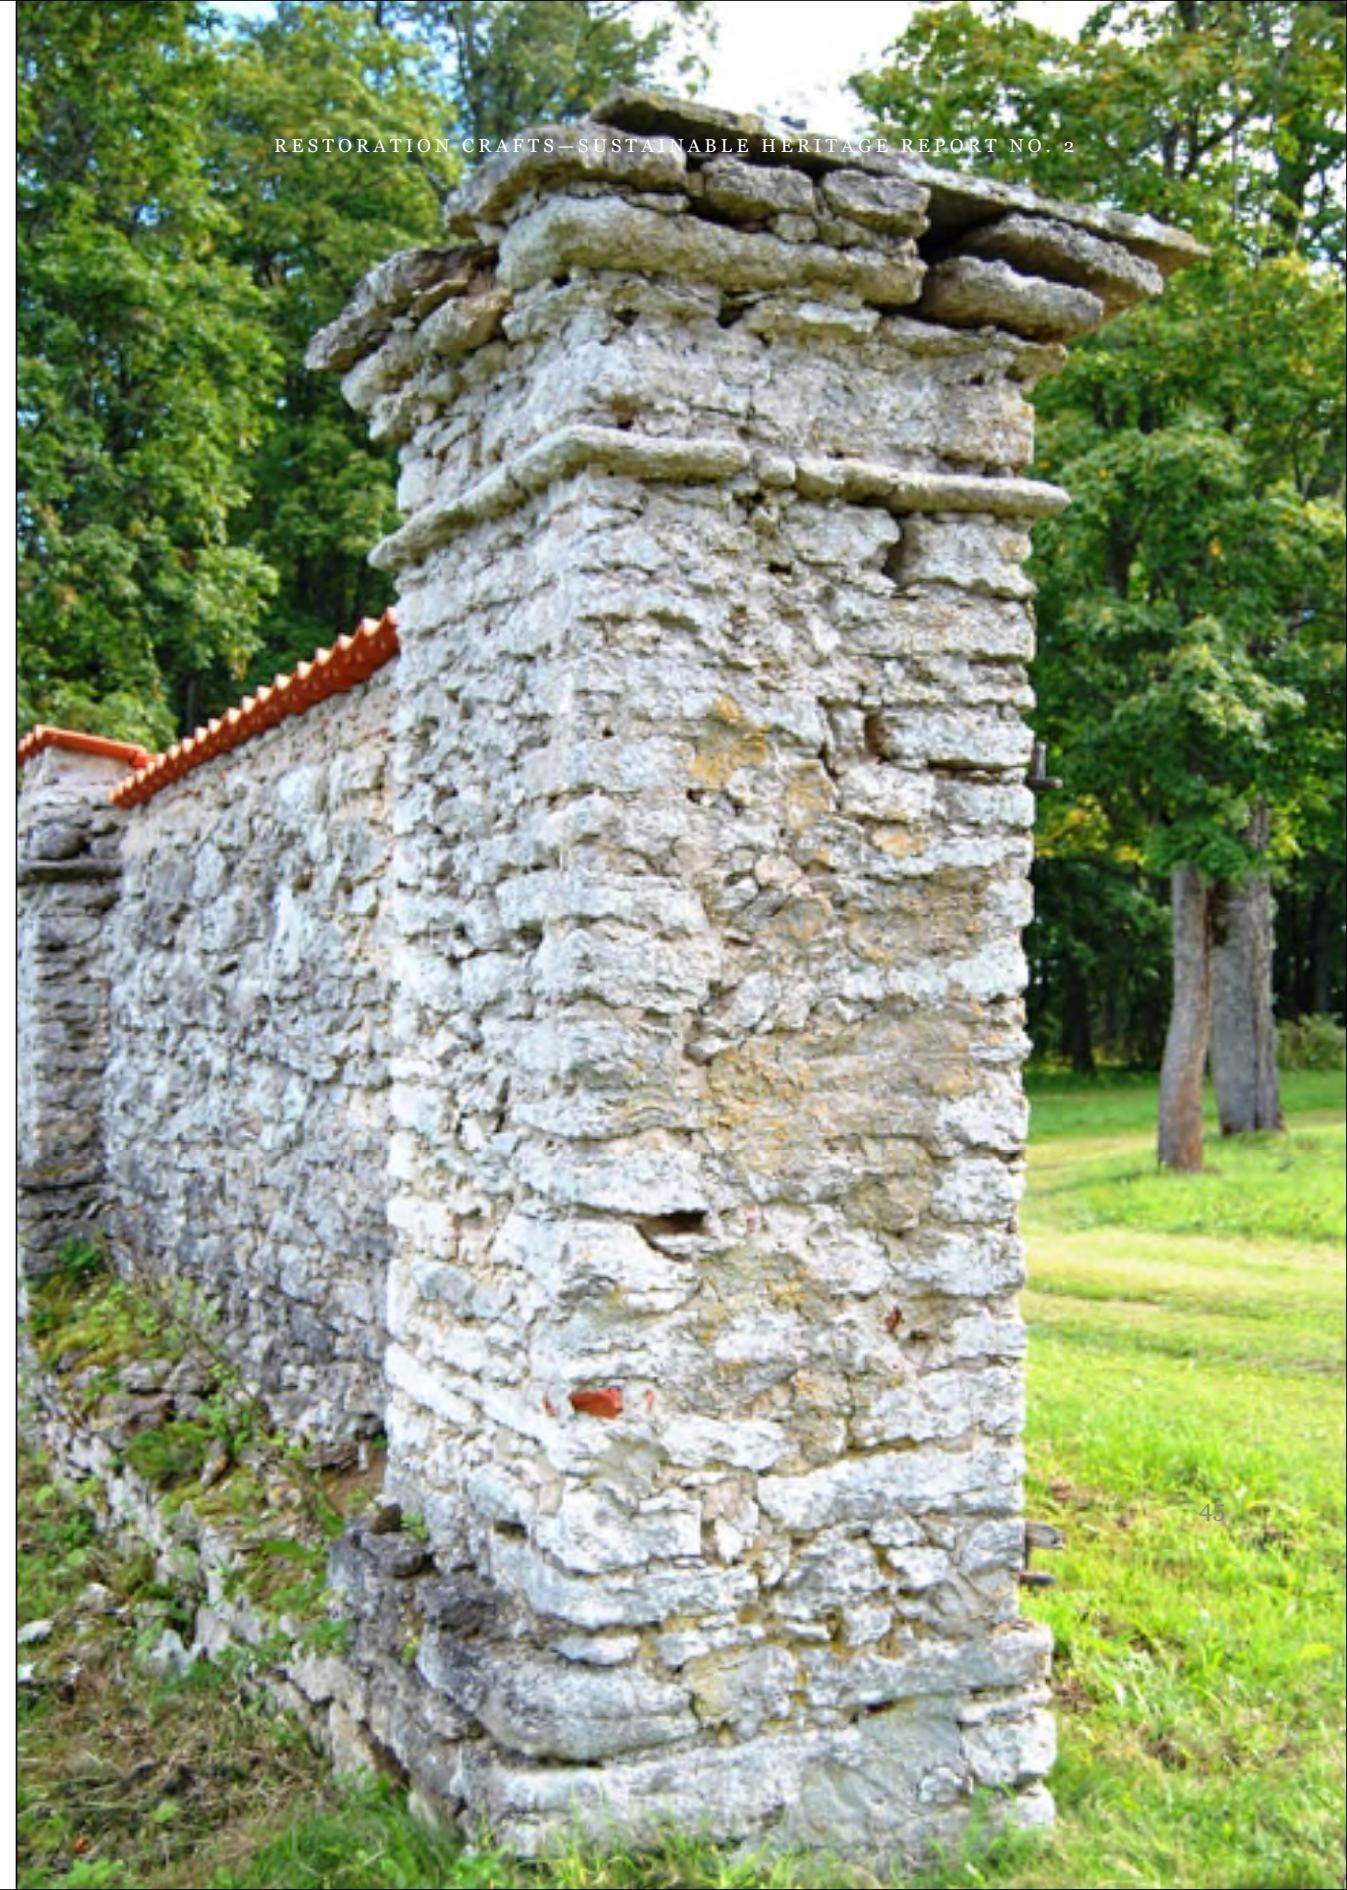
Figure 2.4. Decayed mortar allows rain and frost into the structure thus accelerating the process of deterioration.

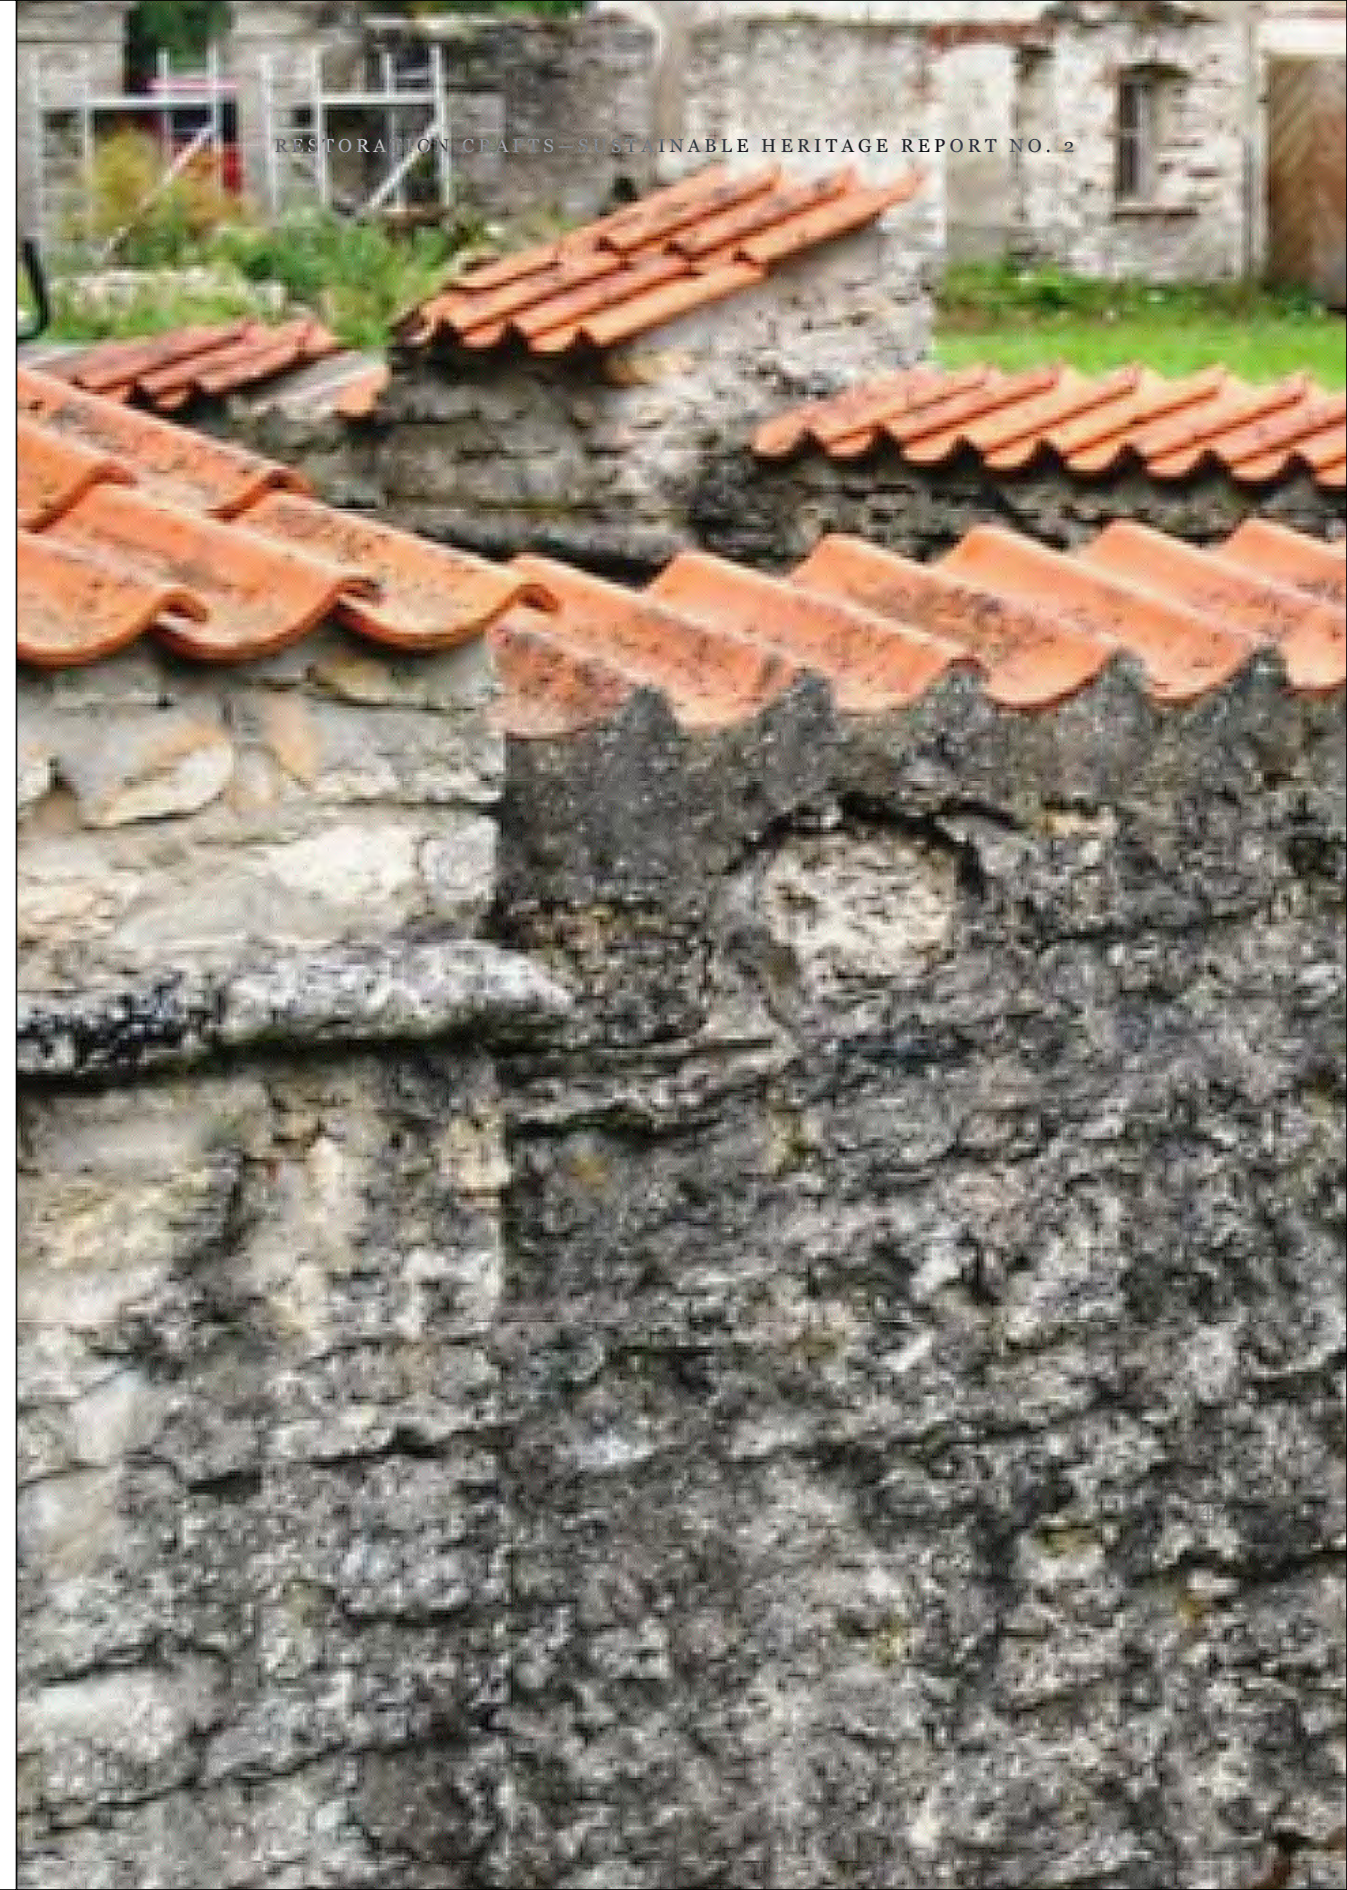
Figure 2.5. The terracotta roofing tiles are a later addition to the wall. The installation might not look very elegant but at least it prevents rain from entering the structure.

Instead of flagstones roofing tiles can be used as a top layer to protect the top of a wall. This is the case on most parts of the garden wall at Seidla Manor. The top of the wall has been built with a slope, using broken roofing tiles as a filling and a cement mortar to fix it together. This is clearly a later addition as the mortar is newer than the old lime mixture, and the roofing tiles are also of a younger date than the wall itself. Some parts of the wall have been left without this addition. There the top layer consists of lime stone and has a slight angle to lead the water off.

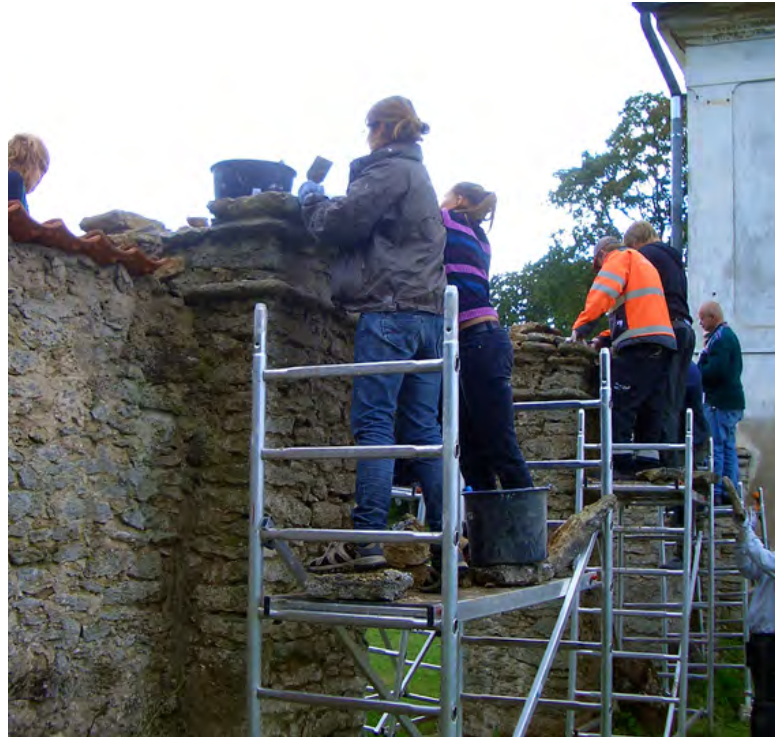
Figure 2.9. Estonian students working on gatepost C in the front; Finnish students in the middle, studying post B, and Swedish students busy with post A in the background.

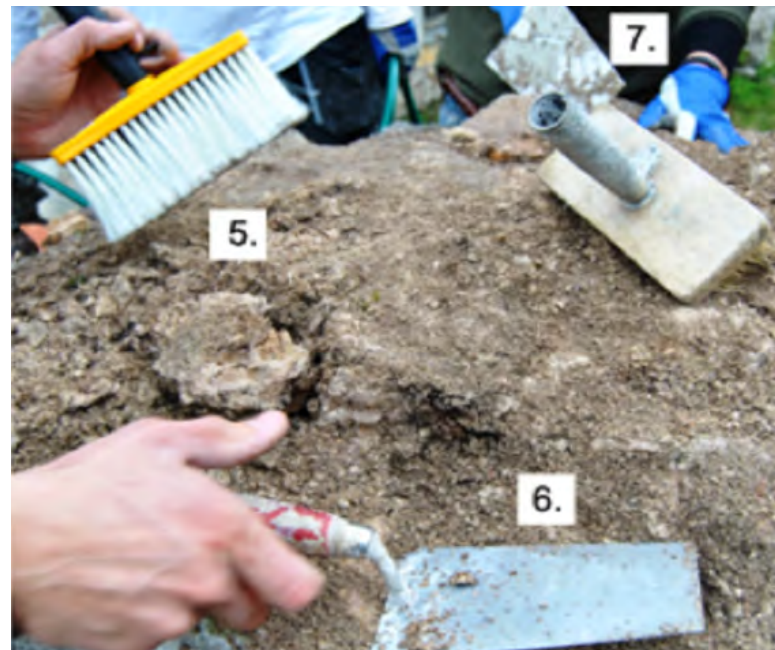
Figure 2.11. More tools: brushes (5)—used to wipe off sand and also to even out mortar on the sides of the posts; trowels (6)—used to apply the mortar onto the wall; waterproof gloves (7)—used when handling the mortar to prevent direct contact with lime; tape measures used for documentation.

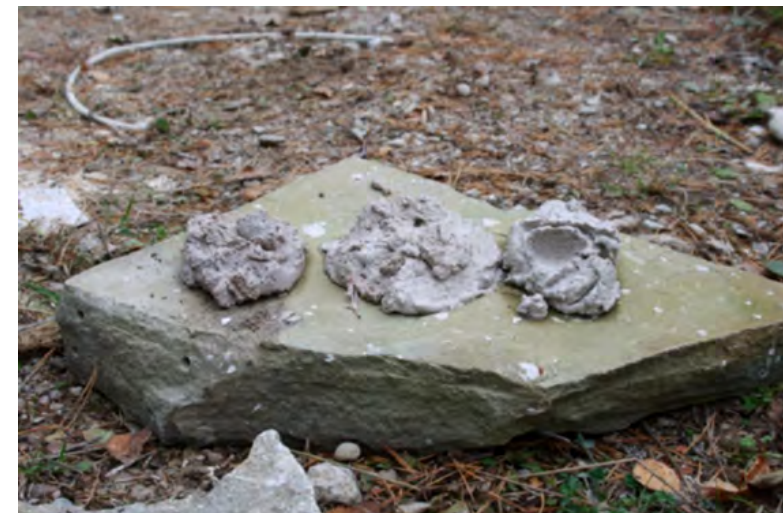
Figure 2.12. Samples of new mortar.

During the documentation it can also be a good idea to take samples of the mortar and render to identify it, either by asking an experienced bricklayer or sending it off to a lab for examination. This will answer the question of what mix to use.

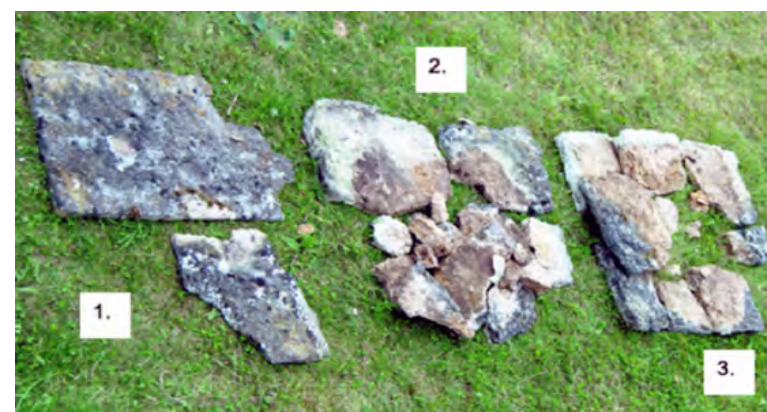
Figure 2.14. Dismantled stones from gatepost: top level (1), second layer (2)—middle part, and right—third layer from top, bottom part of gatepost profile (3).

After the removal of the old plaster and top stones we organized the stones on the ground in the same pattern as they were on the wall.

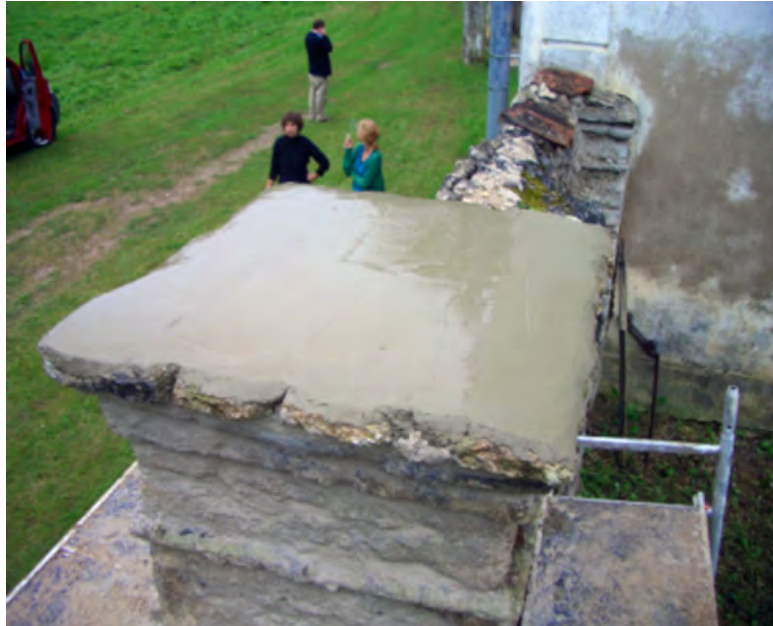
Figure 2.15. The broken flagstones on top of garden posts A and B had to be replaced with a topping of cement mortar because similar new stones were not available.

On the garden posts at Seidla Manor we did not do any rendering, but left them with a rough surface instead. Cavities were filled roughly and the mortar was left to settle over night. On the next day excess mortar was washed and brushed away to match the surface with the rest of the weathered wall.

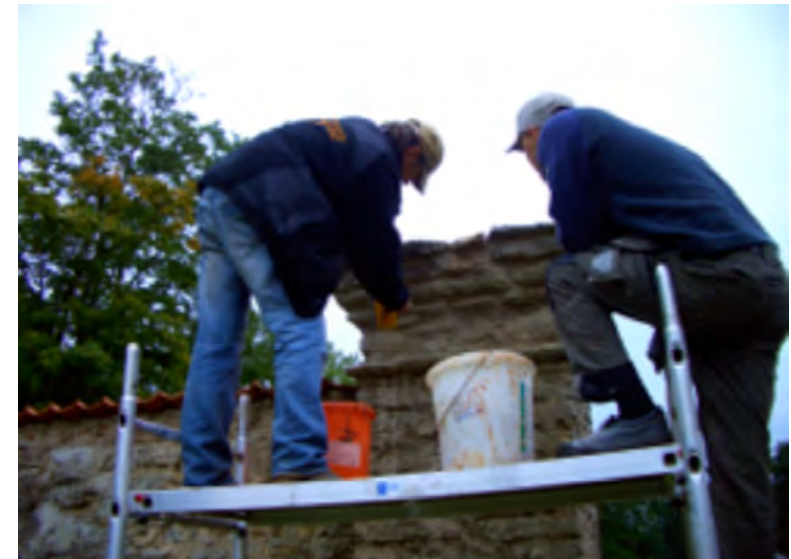
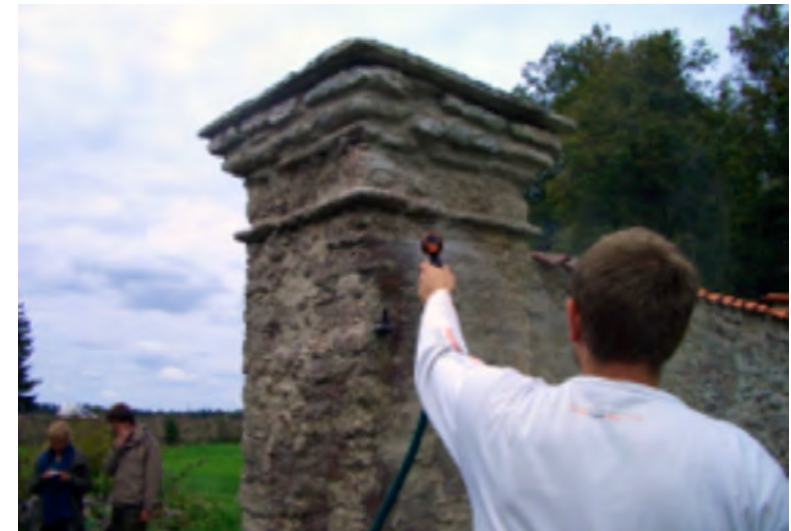
Figures 2.16–17. Finishing touches are being applied on gatepost C.

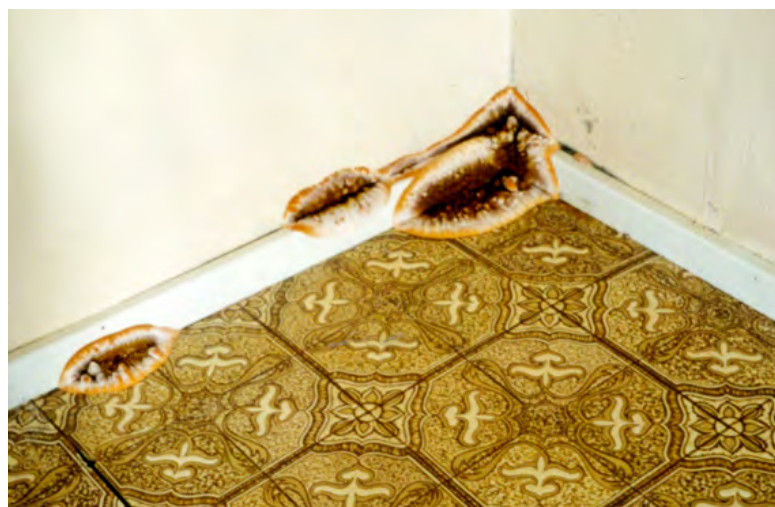
Serpula Lacrymans

Figure 3.1. Fruiting bodies of *Serpula lacrymans*.

The notorious *Serpula lacrymans* (true dry rot) belongs to the group of brown rots. It is found in all parts of the world, mainly inside buildings. It prefers temperatures around +20°C and can survive between +5 and +26°C. It needs oxygen but is sensitive to draught. A 30 – 40 % moisture content in wood is needed and the relative humidity of the air needs to be 95 – 98 %. *Serpula lacrymans* uses ions of calcium and iron (from plaster, rock wool, brick etc.) in the process of breaking down the wood. What makes it so dangerous is its capacity to transport water. Thus it can attack even dry wood and in favourable—or unfortunate—conditions it can destroy a house in a matter of months. The fruiting body smells good, rather like champignons.

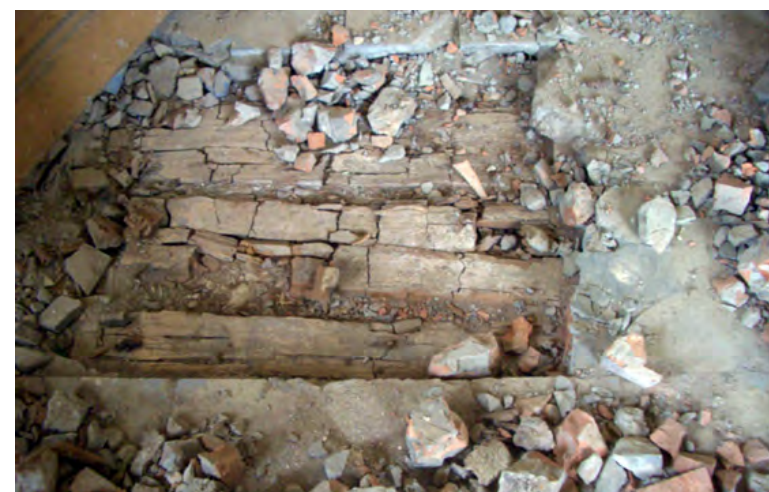
Figure 3.2. Seidla Manor. Floor boards are cracked by fungi. The topmost layer of bricks and plaster has not allowed rising damp to evaporate from the underlying wooden construction.

Seidla Manor had several examples of brown rot. The fungi were not very active since the roof had been repaired and the wood work had dried together with the indoor climate.

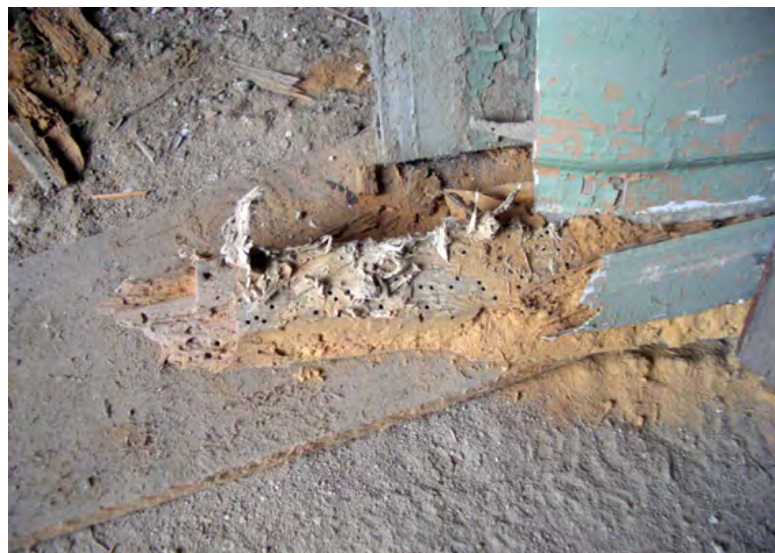
Figure 3.3. Seidla Manor. Top left: brown rot; center: white rot and destruction by wood boring insects.

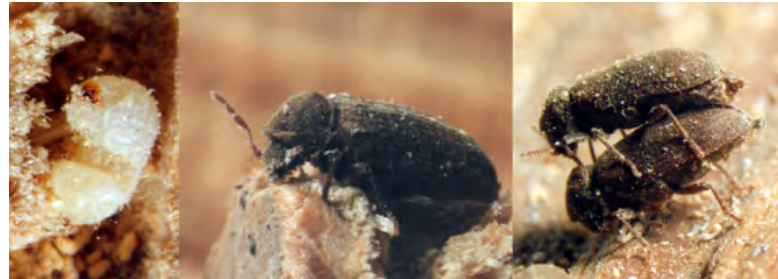
Anobium punctatum

Figure 3.4. Anobium punctatum. Due to its small size this creature is a slow actor in the destruction business. This beetle disfigures antiquities but a day or two in a freezer or out of doors during cold winter days will kill it.

The only really effective, nonpoisonous and sustainable way of getting rid of these insects is to wrap the building up in a tight tent and heating it up to +60 – +70°C. Eight hours of such heat treatment will kill both insects and fungi. Unsound timber must of course be repaired, but if the life within the timber is gone the structure can be left in position as long as it can carry its load. In order to gain permanent improvement the indoor climate must then be changed in such a way that this flora and fauna cannot return.

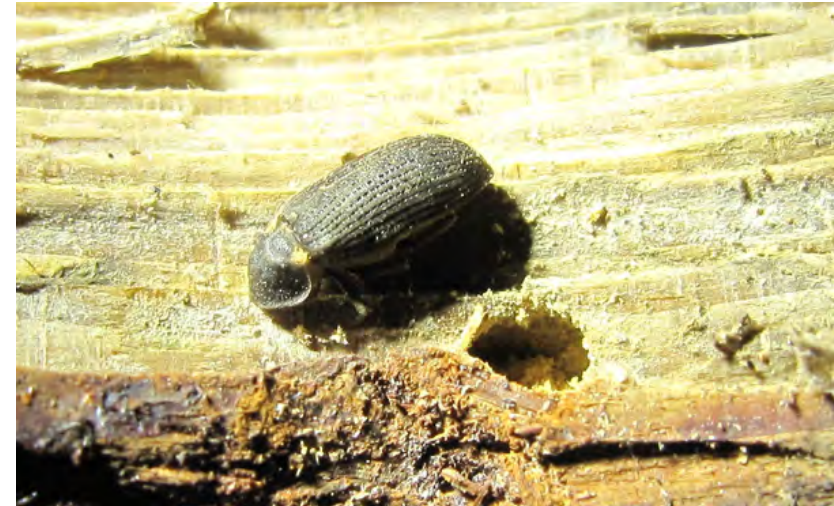
Hadrobregmus pertinax = Anobium pertinax

Figure 3.5. Hadrobregmus pertinax or Anobium pertinax, the insect that causes most trouble in buildings in our part of the world.

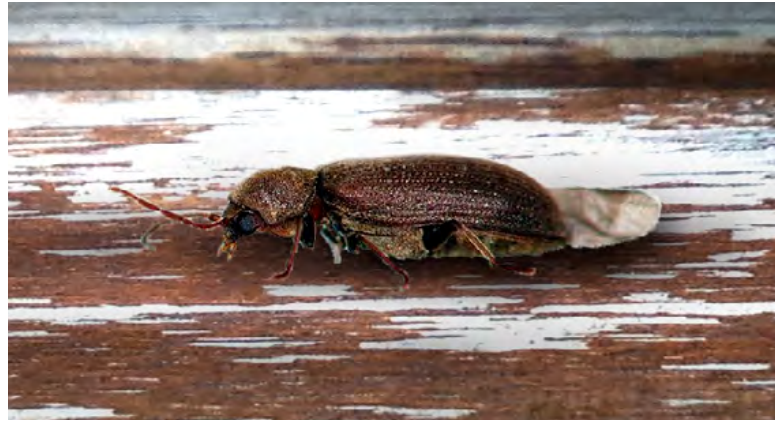
Hadrobregmus confusus

Figure 3.6. *Hadrobregmus confusus* is very much like *Hadrobregmus pertinax* but not so common in buildings.

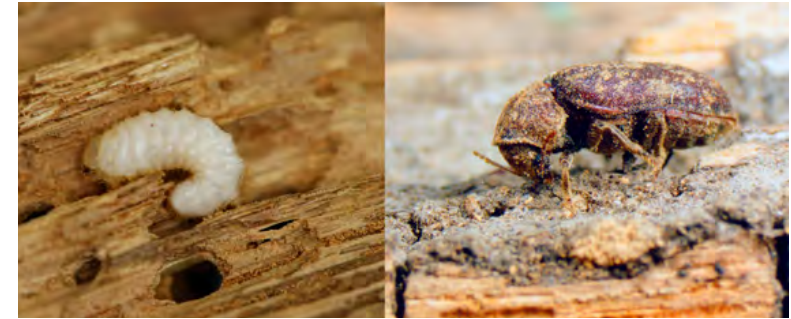
Xestobium rufovillosum

Figure 3.7. *Xestobium rufovillosum*.

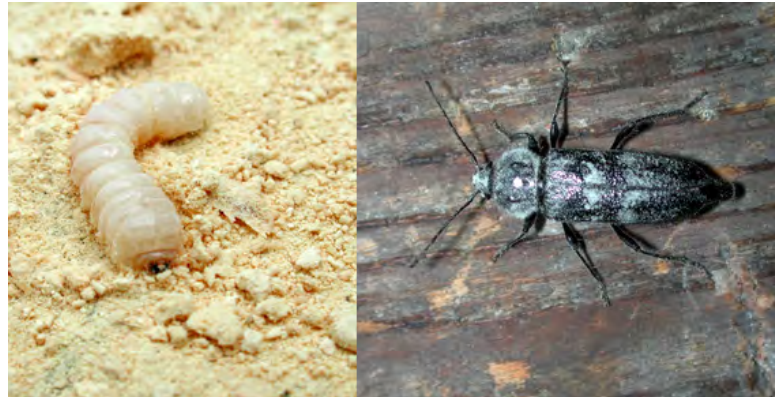
Hylotrupes bajulus

Figure 3.8. *Hylotrupes bajulus*, the most feared visitor in attic spaces. Its big and energetic larvae dig wide tunnels and due to its short life cycle the insect multiplies in large numbers.

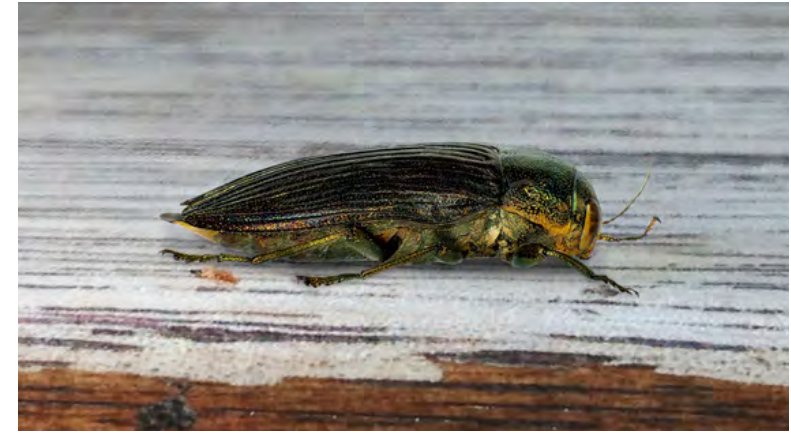
Buprestis haemorrhoidalis

Figure 3.9. *Buprestis haemorrhoidalis*. This beetle can be up to 20 mm long. It likes softwood (pine). The larvae live in dry wood, maybe on the sunny side of a building. Fairly rare in the northern part of the Baltic Sea region but more common the further south you go.

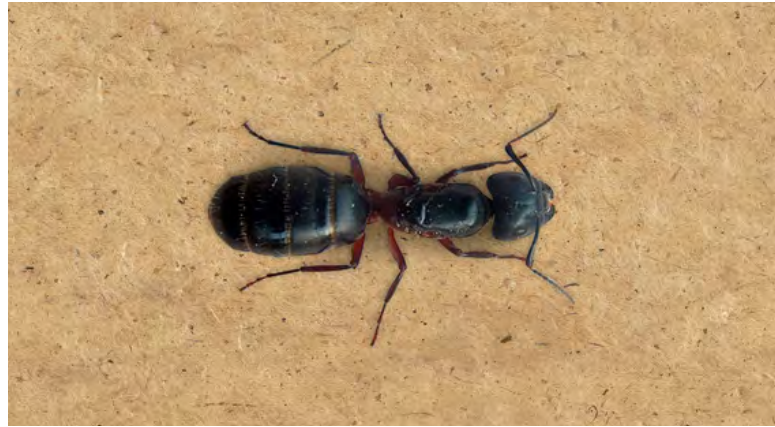
Figure 3.10. Camponotus herculeanus usually builds nests in decaying wood both out of doors and inside timber structures. The damage is usually local but a big nest can cause failure of a structural member. The ant is 6–18 mm long and in one colony there may be thousands of individuals. They are difficult to get rid of but it helps if you find their queen and remove her.

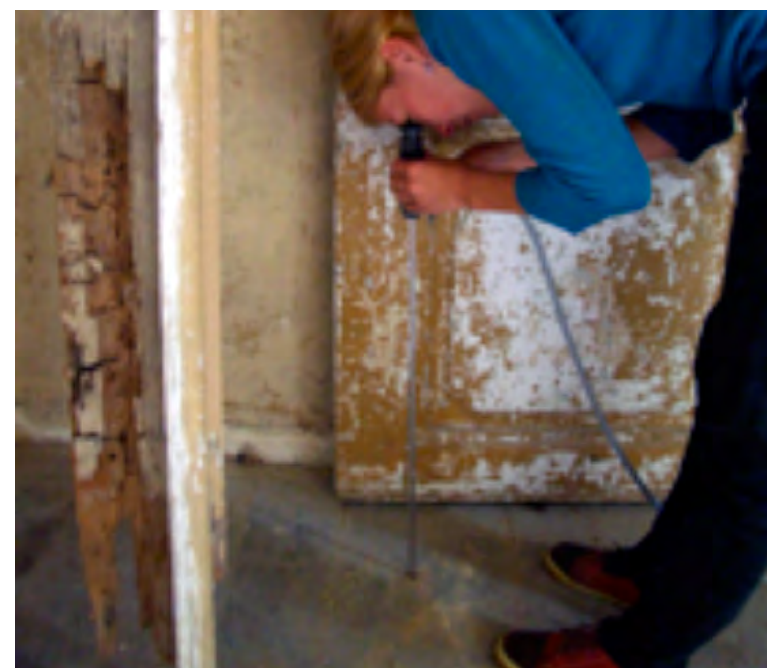
Figure 3.12. Some fungi could be detected underneath the floor boards of the upper hall at Seidla Manor.

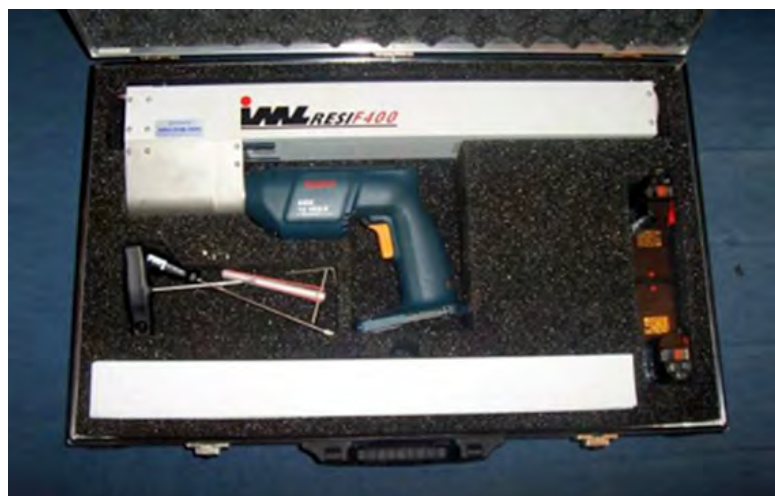
Figure 3.13. Micro drilling apparatus.

Micro-drilling: micro-drilling is the best technique available today for investigating timber. A 1 mm drill probe which is attached to a computer penetrates up to 200 mm into the timber and records faults by measuring the speed of penetration. The extent of decay and its position can thus be determined. The information is extremely valuable for engineers who need to calculate the load bearing capacity of old structural timbers and decide on methods of repair.

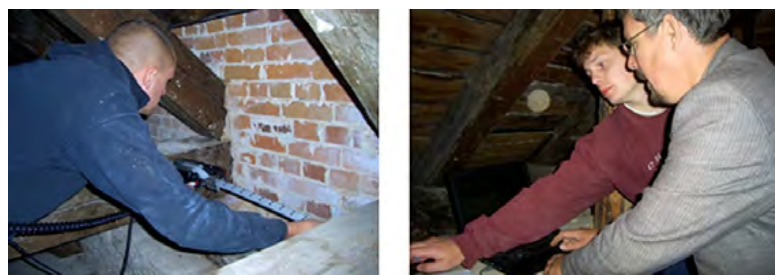
Figures 3.14. One student is drilling into a roof truss while the other is learning to interpret the transmitted information on the computer. Prof. Kalle Pilt, lecturer at Estonian University of life Sciences, (far right) is explaining the curves on his computer screen.

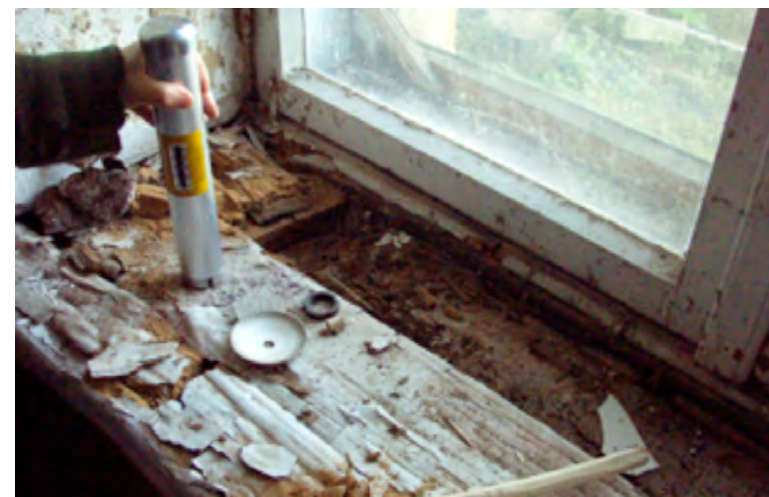
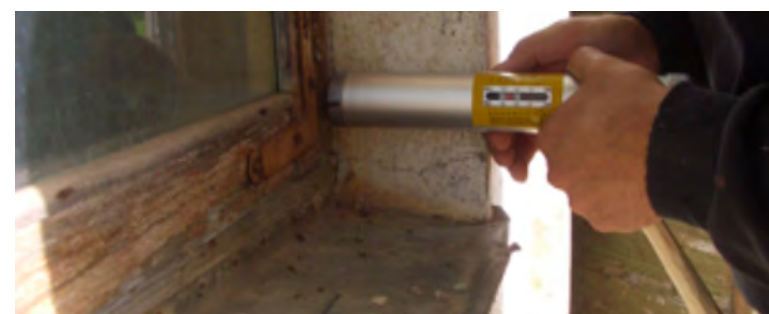
Figures 3.15–16. The Pilodyn was tested on timber with various degrees of decay.

The Pilodyn is used on many different wooden objects for testing the rate of decay as well as wood quality in general, e.g. of railway sleepers, structural timbers in houses, wooden bridges, fence poles...

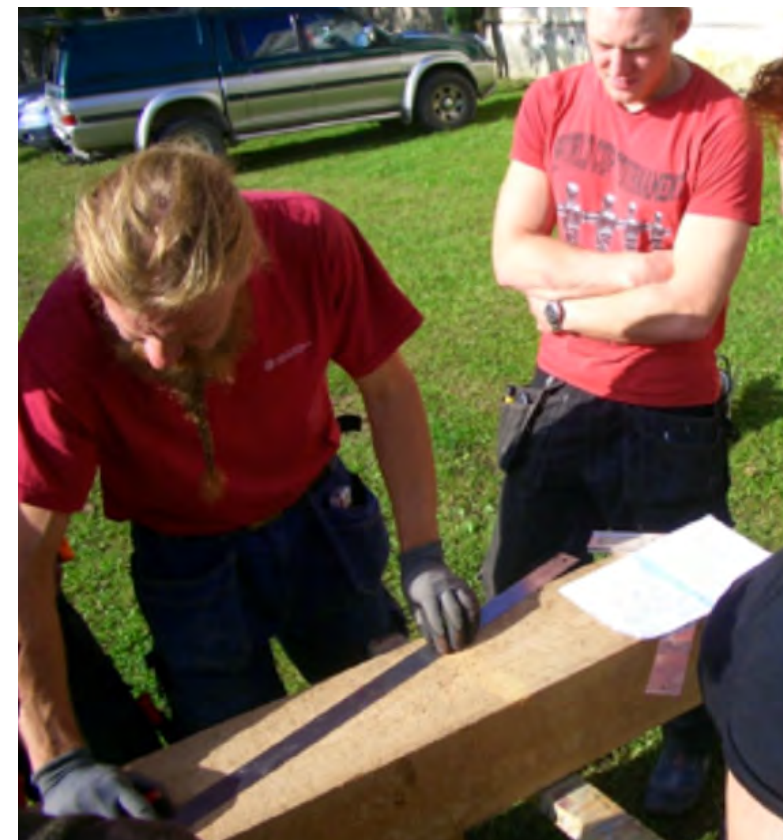
Figure 3.23. Andres Ansper is showing us how to design and draw the joint.

In Seidla we had the chance to try to make a hooked scarf joint or a lapped splice with wedges to lock it. Here are some pictures of our work.

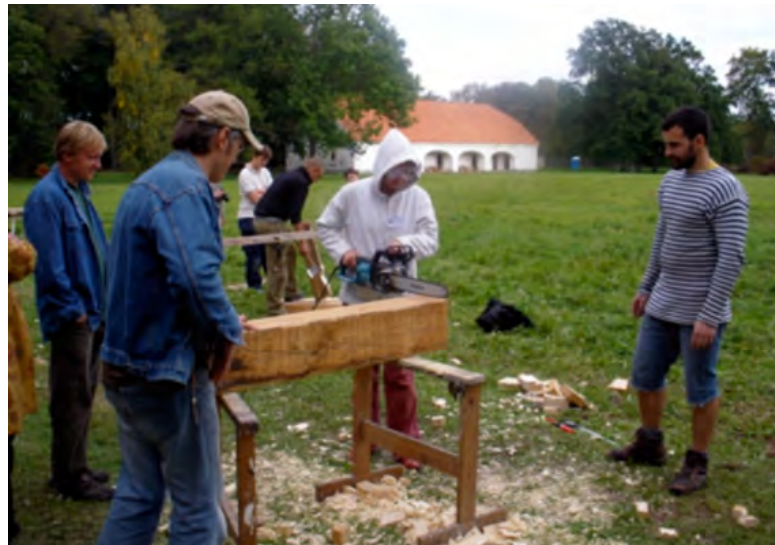
Figure 3.24. Here we are cutting out the splice with a chainsaw. Tarmo Tammekivi (*far right*) is supervising the amateurs.

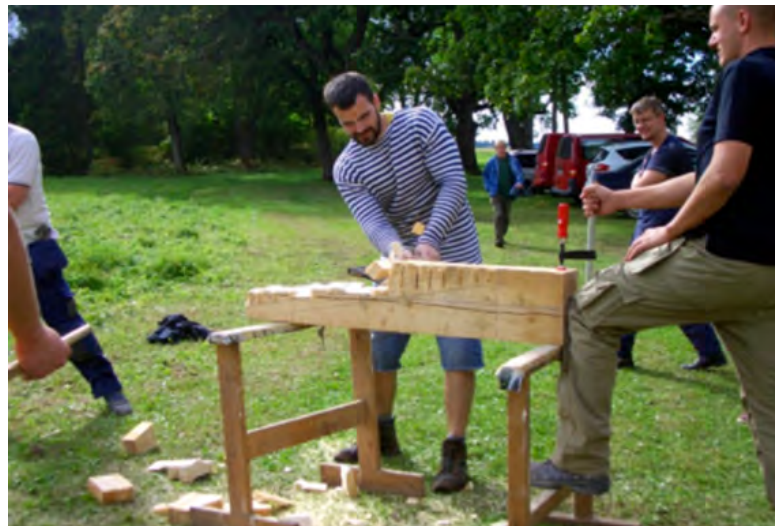
Figure 3.25. Here we learn how to hew the timber with an axe.

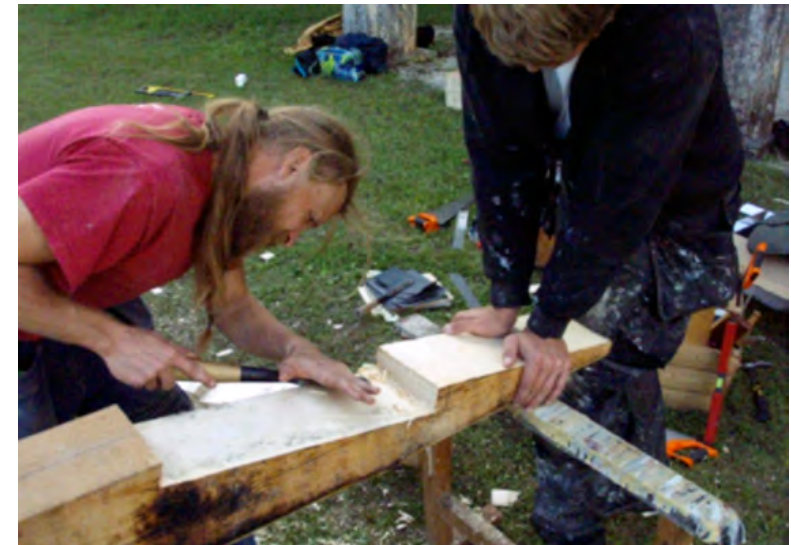
Figure 3.26. Then we learn how to carve with a chisel.

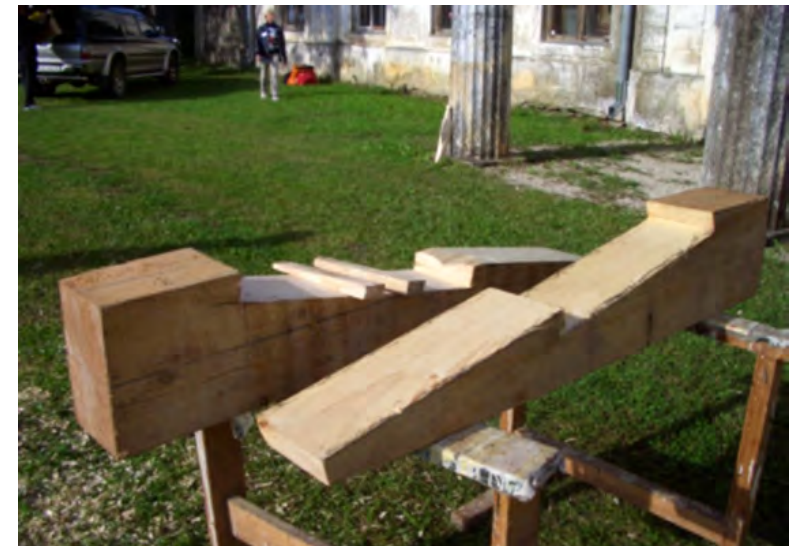
Figure 3.27. Here are the two finished pieces.
