Restoration Crafts and Practises at Seidla Manor in Estonia

—Sustainable Heritage Report No. 2

Novia Publications and Productions,
series S: Student Works, 3/2012

A joint project between Gotland University, Estonian Academy of Arts
and Novia University of Applied Sciences.

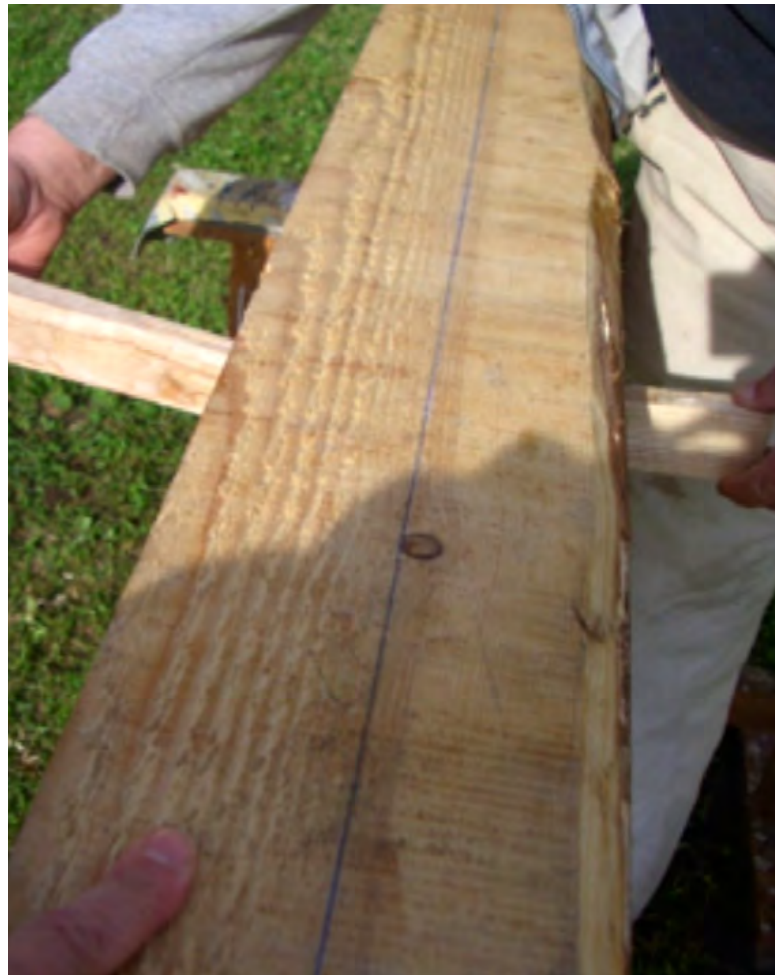
Figure 3.28. Finally we put the pieces together and secure the lock made of two wedges.

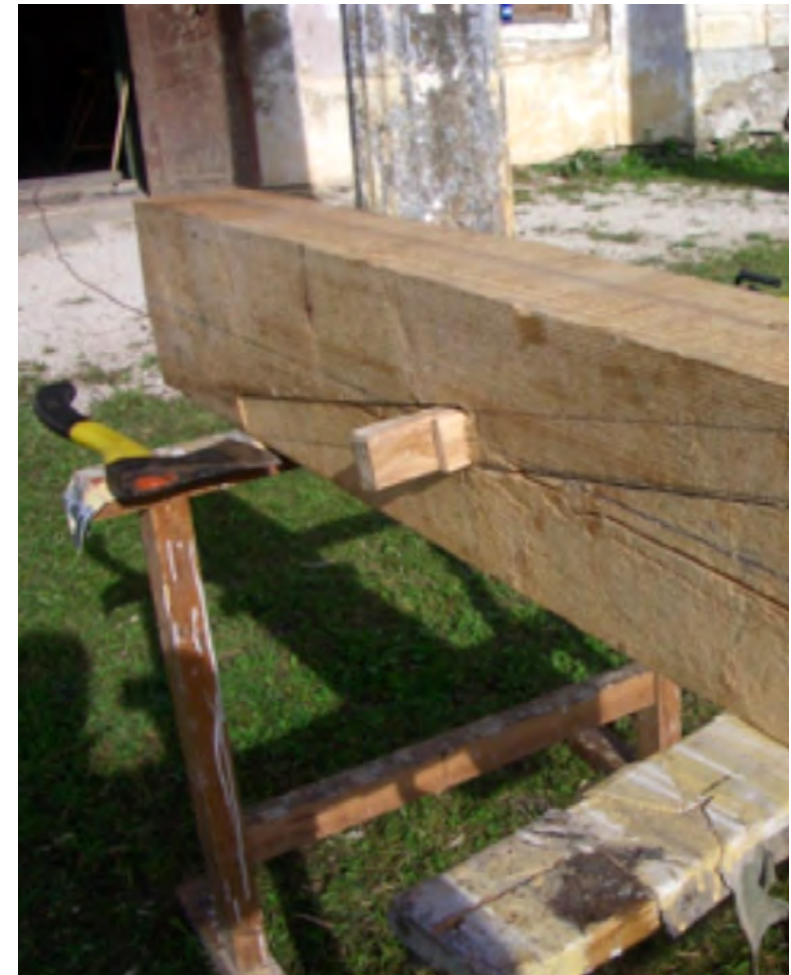
Figure 3.29. Here is a beam joint that withstands tension.

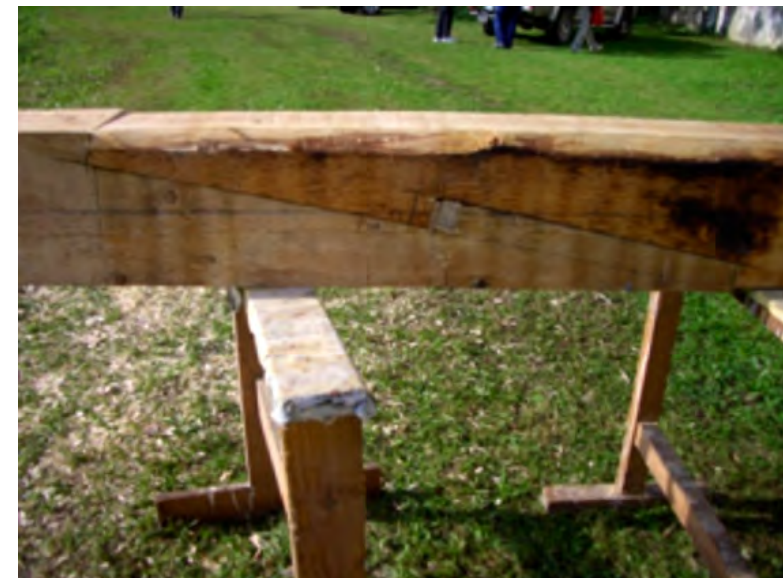
Figure 3.30. The finished joint.

Grinding and fine shaping: now we were left with a large surface that needed to be fine shaped, so that the two beams could be placed on each other. At first the shaping work was done by chisel and hammer, simply pounding pieces away without crossing the lines drawn in the beginning. When the wood started to take a finer form the work continued with the help of a plane. With the plane, the area that was to meet with the corresponding area of the other beam, was made smooth and nice so the two beams could meet exactly.

The key: the key ensured that the beams would not and could not separate. If you look from the side of the beam the wedge hole is square. When the two wedges are pounded in place from separate sides they secure the entire construction as planned.

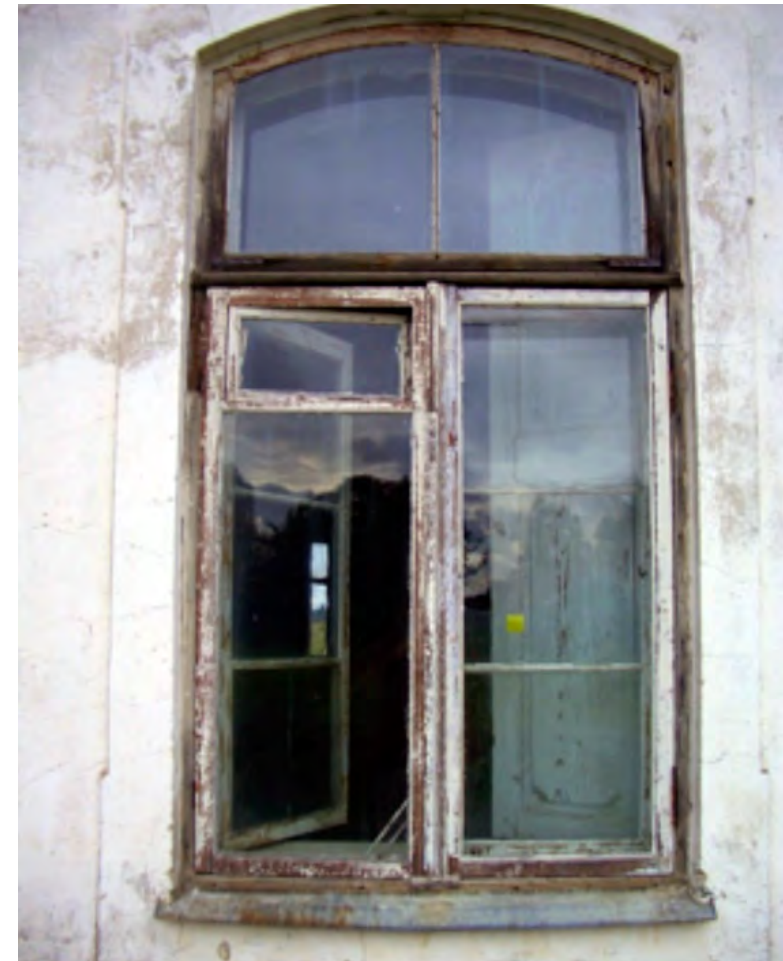
Figure 3.32. A typical window at Seidla Manor. Much work will be required.

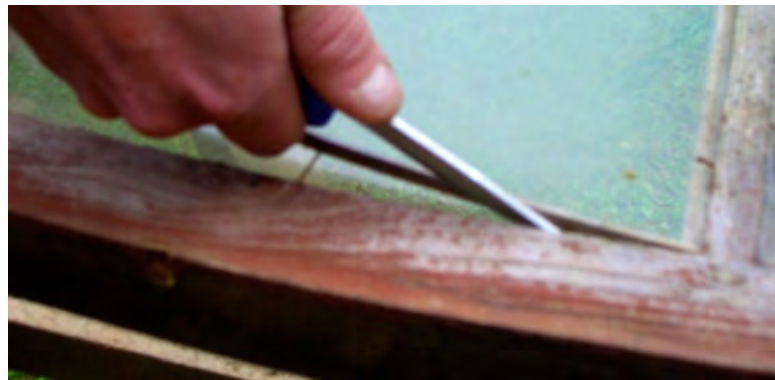
Figure 3.33. A glazing bead is being removed.

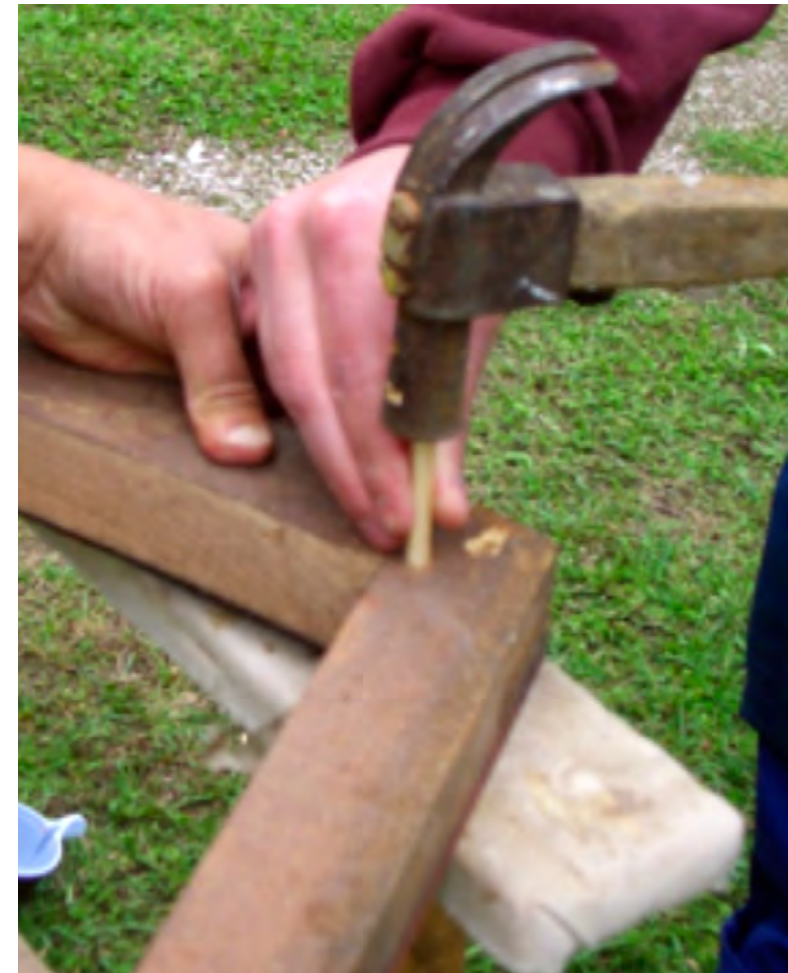
Figure 3.34. A new peg is being pounded gently into the casement of a window.

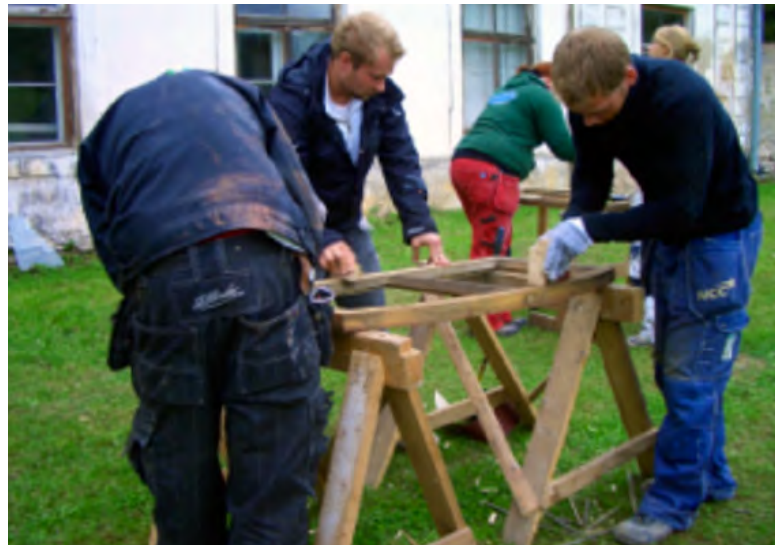
Figure 3.35. Sandpapering was quite easy as there was only one coat of paint to be removed and the wood was mostly in good condition.

Finishing: when the grinding part was over it was time to prime the surfaces with linseed oil. A few days later we could start reinstalling the glasses. The casement was placed on the worktable so that the inside of the window was down. A 1–2 mm thick bed of putty was pressed in the glazing groove. Then the glasses were reset on the bed of putty and pressed tight so that no air was left between glass and putty. When the glasses were in position small pieces of wood were pressed around them to keep them from sliding sideways. Next they were secured with the help of some small nails (preferably glazing points) which press the glass down as they are gently hammered into the surrounding wood. Finally the putty is inserted and trimmed with a putty knife so that it covers the nails and the groove (which is visible through the glass). Because traditional putty has the same binding agent as the paint, i.e. linseed oil, it can be painted as soon as it has been applied. Indeed, it is very important to paint it within a week or so to save it from drying and cracking.

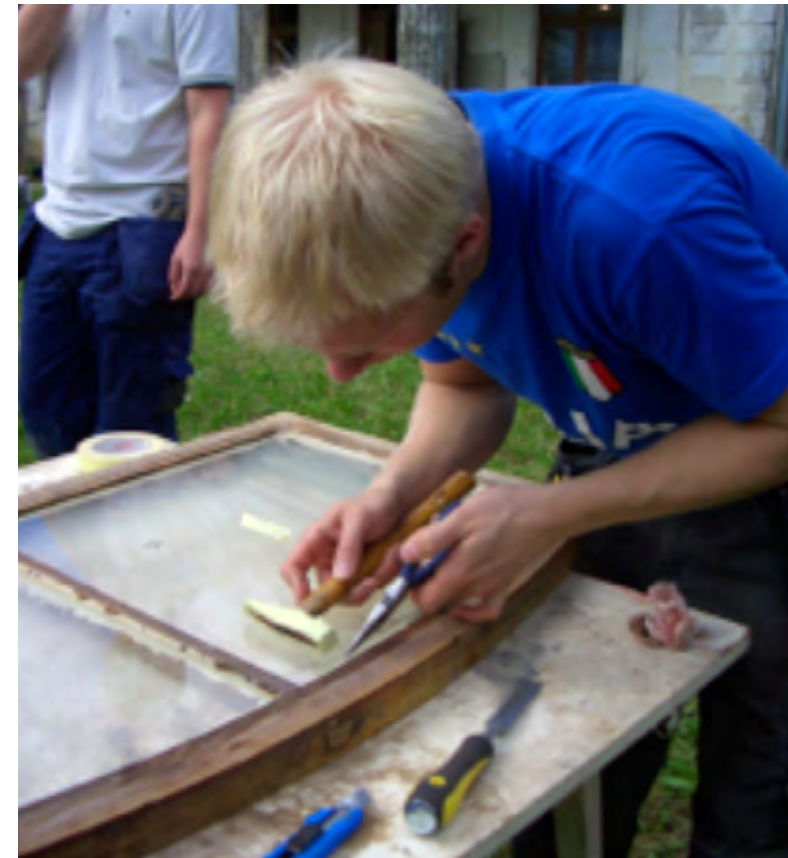
Figure 3.36. Nails are being inserted. The small hammer is wrapped in masking tape to avoid scratches on the glass.

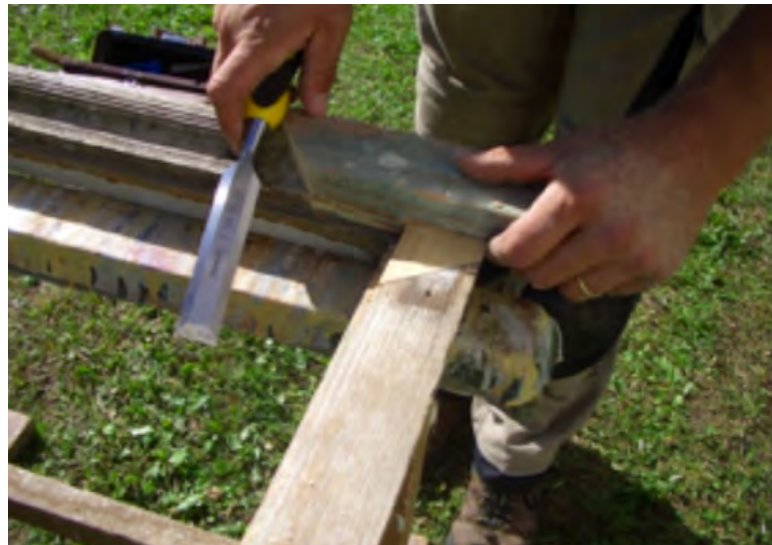
Figure 3.37. A new piece of wood has replaced an old decayed part.

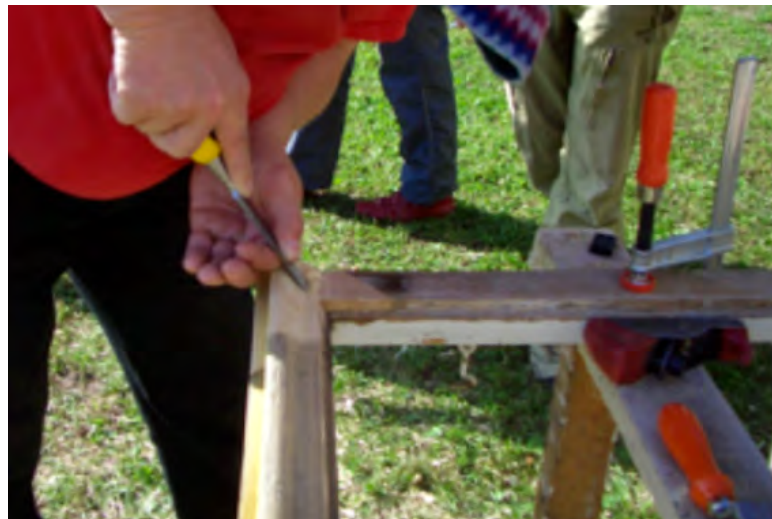
Figure 3.38. The new patch of the weather moulding is being shaped to match the old parts.

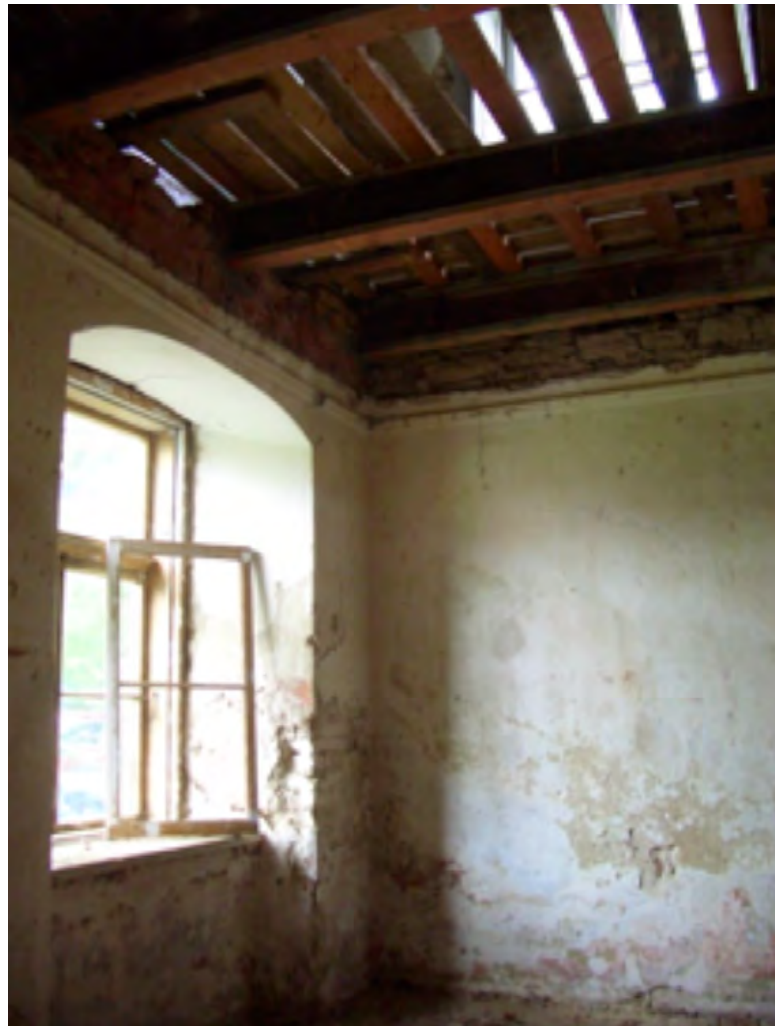
Figure 3.39. In some of the rooms at Seidla Manor there was neither ceiling nor cornice. Everything needs to be rebuilt.

If a complete reconstruction is to be done, the starting situation for the cornice work should be the following:

- The walls (at least the upper parts of them) and the ceiling need no further repair or replacement of construction parts.
- Loose parts of the walls and old plaster are removed.
- Ensure that fixing of the new cornice to the walls and the ceiling is possible with appropriate methods depending on the construction materials used for each construction part.

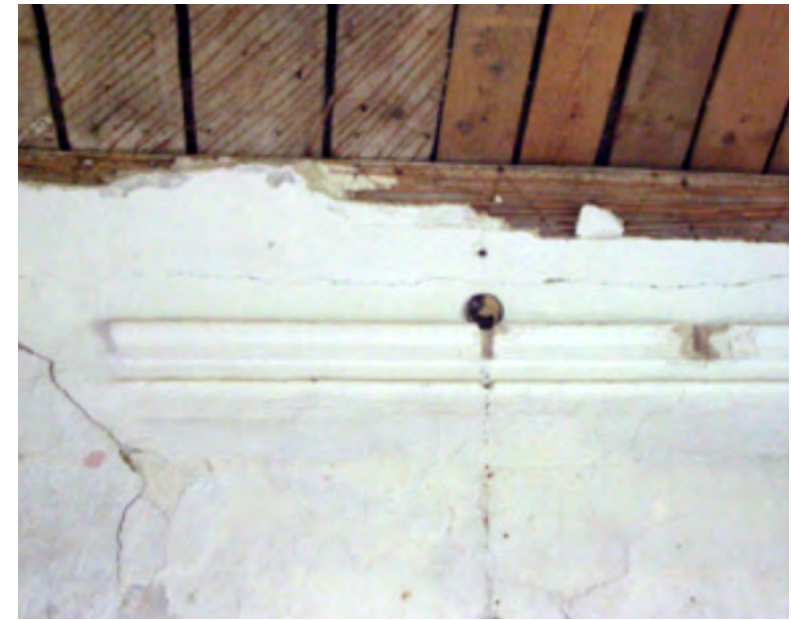
Figure 3.40. Plaster is removed from the ceiling and partially from the cornice. The ceiling needs insulation and the attic floor is missing, too. However, the timber frame of the cornice is most likely in good condition. The shape of the old cornice is possible to replicate.

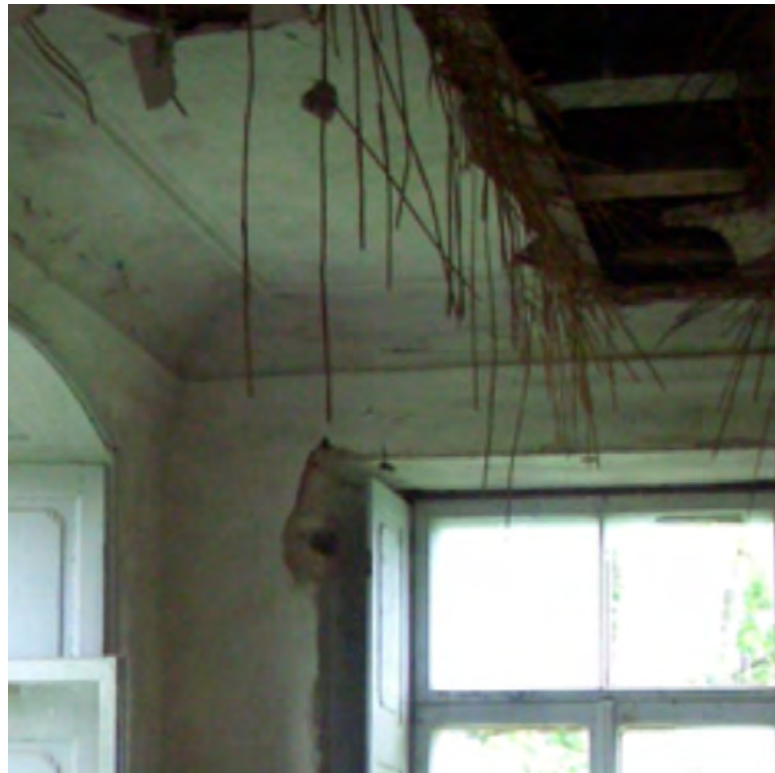
Figure 3.41. In some of the rooms at Seidla only the paintwork is damaged otherwise the cornice is in good condition.

If only the finishing coat is to be renewed dust and fat must be removed from the surfaces before treatment.

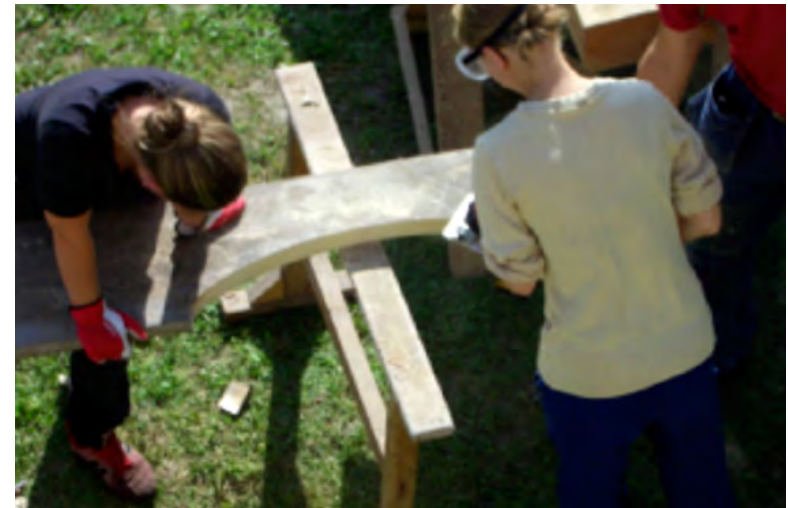
Figure 3.42. Consoles for the upper hall cornice are being made.

Plastering: when preparatory work is done, form the consoles to the desired shape using appropriate tools, e.g. a jigsaw. Fix the framework of the cornice to the walls and the ceiling. Attach a reed web, or a plastic mesh, using staples or nails to the wooden surfaces that are to be plastered. Mix the plaster according to the original recipe and start applying this to the framework of the cornice. The plaster can be applied by throwing, pressing or spraying. The shaping of the cornice starts after the first layer of plaster has been applied. The shaping is done by dragging a stencil made of plywood, which is cut to the desired shape, along steering planks on the wall and the ceiling. The stencil can be reinforced with a metal plate. The shaping is done in as many layers as required. Do not apply too much plaster at a time.

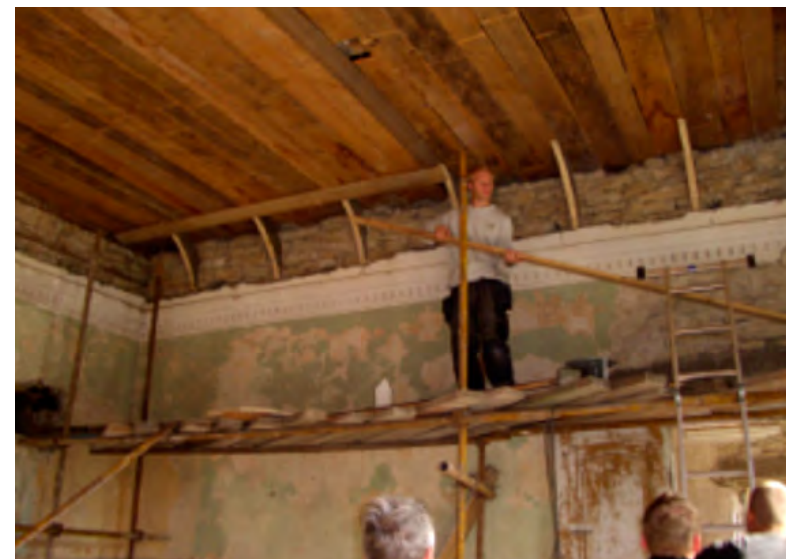
Figure 3.43. In the upper hall: new consoles are in place and planks are being attached to these. We finished the woodwork for the cornice along one wall.

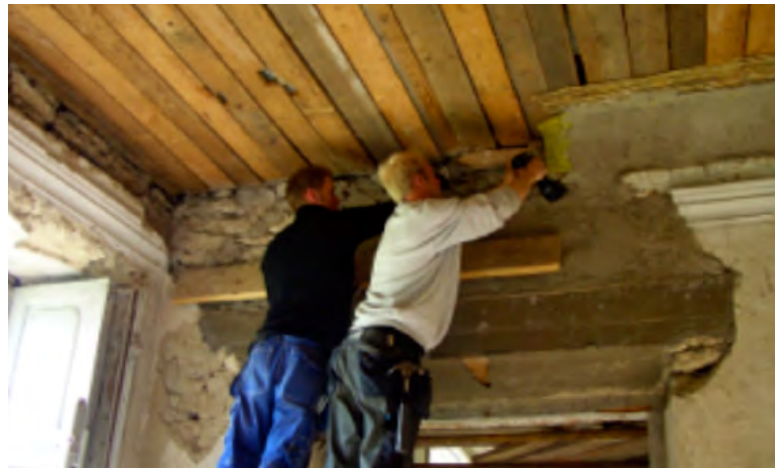
Figure 3.44. Reconstructing a cornice in one of the badly damaged rooms on the upper level.

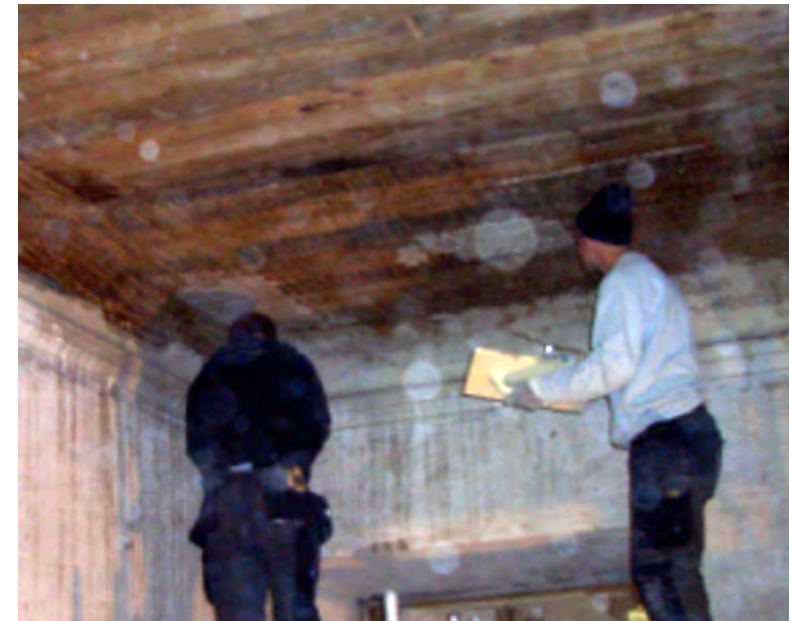
Figure 3.46. We were given a chance to try the traditional method of plastering the reconstructed cornice. This job is definitely something for experts!
